**WUPPERTHAL**  
**REBUILDING HOMES AFTER THE FIRE OF 2018**

**John Wilson-Harris**

Director, Gabriel Fagan Argitekto Inc.

28.04.2024

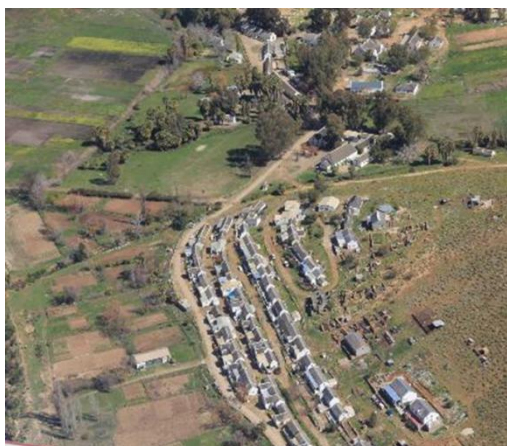
Fig 4 Before (Fai-Ter-Ral-Boy, Dublin, NZ)

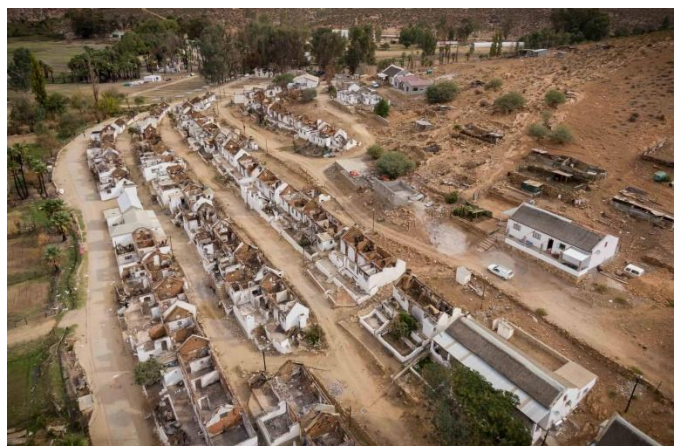
Fig 5 After (Halden Krog)

The fire of 2018 claimed one life and left some 200 people homeless. Public donations of money, clothing and consumables were made. Each household was eventually apportioned R72,000 from donations for rebuilding. The Department of Human Settlements constructed temporary housing on the village rugby field. Heritage Western Cape visited the village to assess the damage.

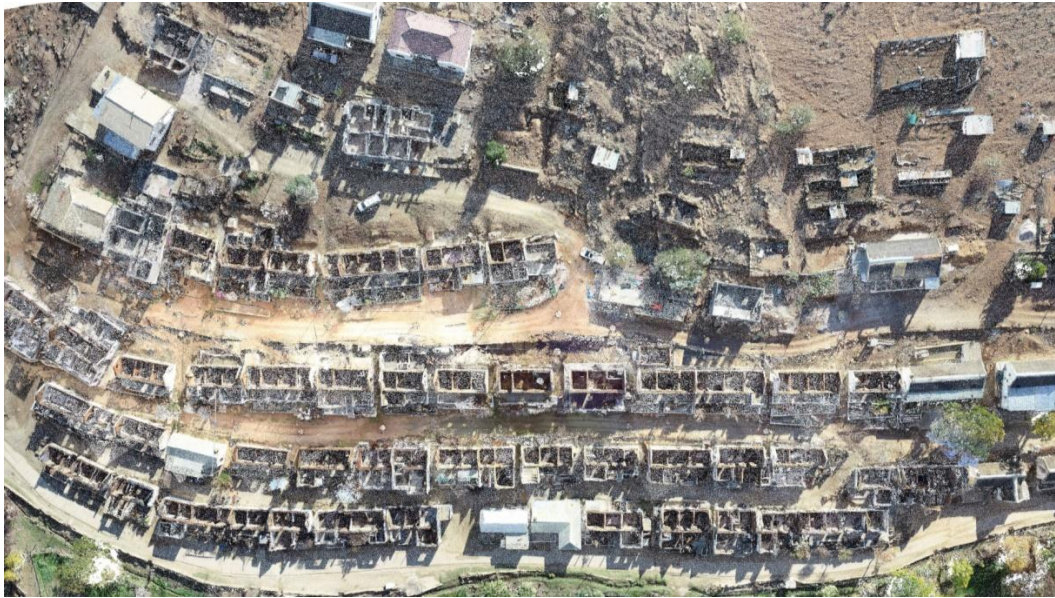
Fig 8 Point cloud survey - drone (Cape Survey, 2019)

After approaching various surveying practices to perhaps assist with developing the basic layout drawings, Cape Survey offered pro bono assistance. They offered to undertake a point cloud scan of the buildings using a drone, augmented by scanning at ground level. After numerous delays in getting the drone down to Cape Town, it eventually arrived in Wupperthal on a stormy weekend in May 2019. Because of the inclement weather, the operators were only able to survey part of the settlement, and although architectural practices had offered the use of their software and expertise to translate the scans into usable documentation, the results were vague and not definitive (Fig 8 and 9). It was concluded that CIFA would have to find volunteers to measure up the buildings on site.

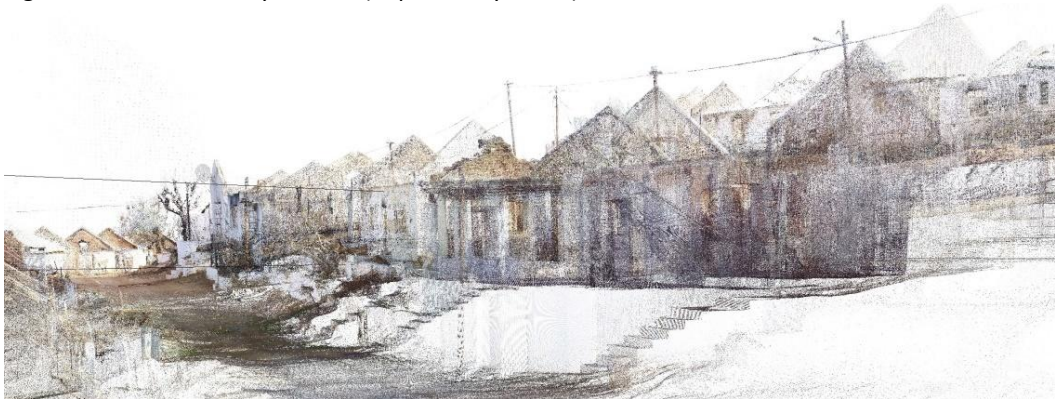
Fig 9 Point cloud survey - terrestrial (Cape Survey, 2019)

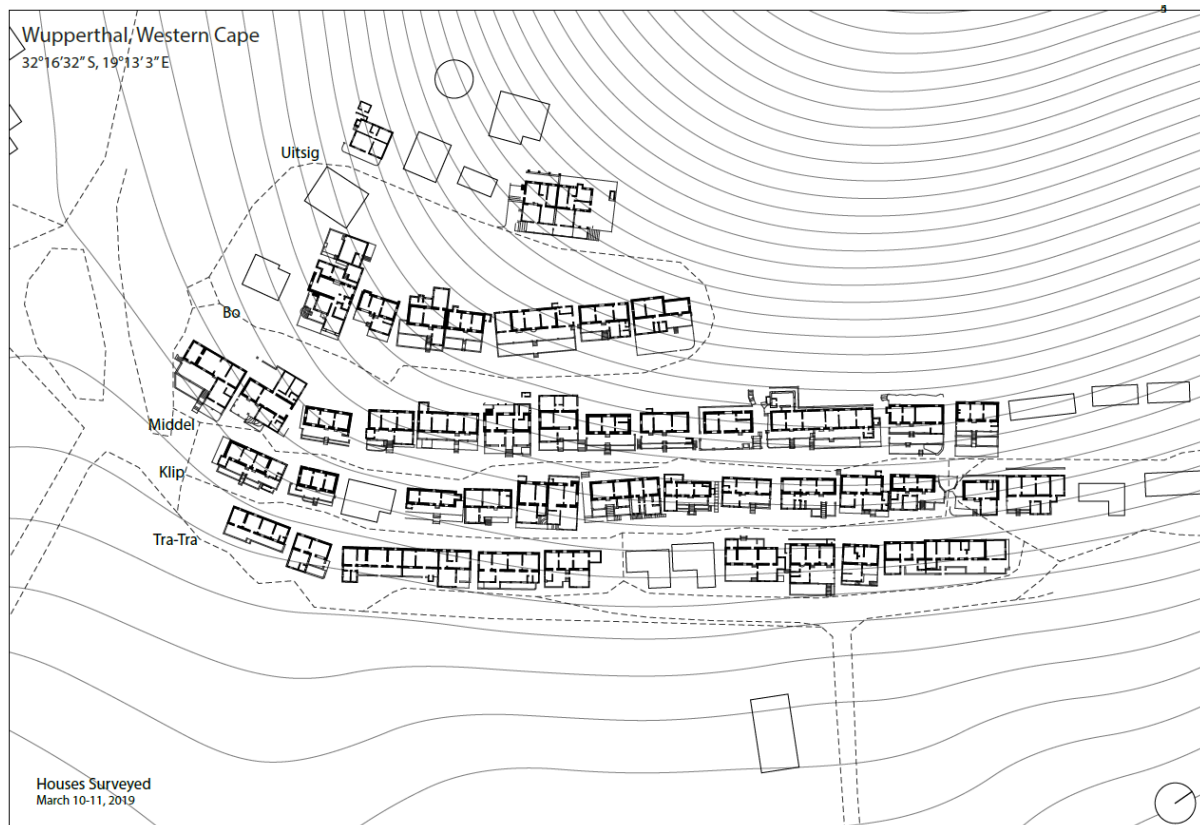
Fig 13 – Students' compiled town plan (van Jaarsveld et al., 2019).

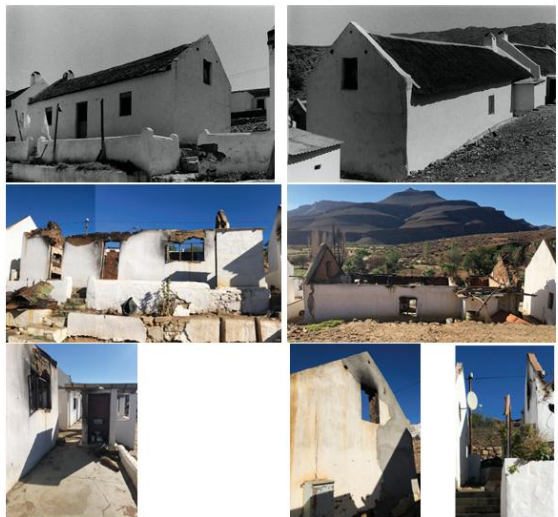
Fig 14 - 9 Middle Street - Heritage Assessment page (CIFA)

**IMAGES** (Left to right from top row):

1. 1979 photograph of the front of the house from Middle Street (Revel Fox and Partners, 1979).
2. 1979 photograph of the back of the house from Bo Street (Revel Fox and Partners, 1979).
3. Front elevation of 9 Middle Street (SEA student survey, 2019).
4. Back elevation of 9 Middle Street (SEA student survey, 2019).
5. Photograph of the toilet block that had been added onto the stoep after 1979 (SEA student survey, 2019).
6. View of the north-east gable (SEA student survey, 2019).
7. View of the south-west gable (SEA student survey, 2019).

The assessment format was standardised. It incorporated a statement of significance, the basic information about the house, its description, alterations proposed, comment from the residents, and recommendations (Fig 14).

<b>SITE NAME: 9 MIDDLE STREET, WUPPERTHAL, WESTERN CAPE</b>									
<b>PHYSICAL ADDRESS</b> 9 MIDDLE STREET, WUPPERTHAL, WESTERN CAPE									
<b>ERF/FARM No</b> FARM 168, CLAN WILLIAM									
<b>CO-ORDINATES</b> -32.275199, 19.217985									
<b>OWNER</b> MARIA MAGDALENA WYNAND									
<b>OWNER'S ADDRESS</b> 9 MIDDLE STREET, WUPPERTHAL, WESTERN CAPE									
<b>OCCUPANTS</b> 3									
<b>ARCHITECT/BUILDER</b> UNKNOWN <b>DATE</b> c. 1850									
<b>ORIGINAL USE</b> RESIDENCE <b>CURRENT USE</b> RESIDENCE									
<b>PROTECTION AND GRADING</b>									
±60 YEARS	YES	NATIONAL MONUMENT	NO	GAZETTE NUMBER	N/A	NHRA PROTECTION	S31	PROPOSED GRADING	IIIC
<b>STATEMENT OF SIGNIFICANCE</b>									
<p>The house is part of the group of similar houses, which together form a streetscape of heritage significance. This house is located within the proclaimed Wuppertal provincial heritage site area. The regularity of form, materials, openings, scale and roof pitch; the slight irregularity of size and positioning relative to neighbouring houses, and the consistent manipulation of the sloping site into various terraces fronting onto the road give the streetscape variety, shaped by organic growth and a controlled uniformity created by the restricted palette of available building materials. The house at 9 Middle Street contributes to this grouping. The proposed grading for the house is IIIC.</p>

<b>SITE AND STRUCTURE ANALYSIS</b>									
<b>DESCRIPTION</b>		<p>The house follows the 'langhuis' typology with straight end gables on the shorter sides and a double pitched (40 – 45 degrees), thatched roof between, with a three-room layout. There is a roof loft door in the north-eastern end gable. By 1979 the house had been extended towards the Bo Street with a small, 'afbak' addition on the back. A freestanding toilet block has been constructed on the front stoep. Both structures were under shallow, mono-pitched, corrugated iron roofs. The elevated front stoep walls are plastered but with some sections of stone-coursing visible, and the lower terrace on Middle Street has similar low walls. There is no evidence of a pergola or trellis in both the 1979 photograph and the recent images. The stoep is accessed via a central, front stair. The house has two doors facing onto the stoep (the central one into the living room, the southern door into the kitchen), as well as a horizontal, steel window with three divisions. A small-paned, steel casement window into the living room is located along the back elevation of the house. A similar steel casement window has been constructed in the southern gable.</p> <p><b>Roof</b> – The main roof, thatched on timber trusses, has been burnt. The small extension to the back and the toilet block on the stoep are roofed with metal sheets that allowed for minimal pitch, and this roofing remains.</p> <p><b>Walls</b> – Clay brick for the core historic 'langhuis'. The front and back additions are of cement block. There is widespread plaster delamination and softened clay brick surfaces, with structural cracking in the add-on rooms built from concrete blocks. There are some shear cracks above the window openings with lintols and door heads collapsed.</p> <p><b>Doors &amp; Windows</b> – Two intact steel windows. All timber doors have been burnt. Roof loft door has been burnt.</p> <p><b>Chimney</b> – Traditional chimney evident in 1979 photographs in southern kitchen gable.</p> <p><b>Floors</b> – The stoep has been surfaced with a cement screed.</p> <p><b>Retaining wall</b> – It appears that all of the retaining walls, front and back, are of packed stonework. The stoep walls have been partially plastered and the walls have been painted white. All appear to be in fair condition.</p>

<b>ALTERATIONS</b>		<p>Extension to the back of the cottage was done before 1979, and the addition of the toilet block after this date.</p>							
<b>OWNER'S REQUESTS</b>		<p>The owner would like the toilet removed from the front stoep, and a new bathroom constructed to the back of the house, and a metal roof, instead of thatch, due to concerns about fire.</p>							
<b>RECOMMENDATION</b>		<p>The owner's layout request can be accommodated with little impact on the significance.</p> <p><b>Roof</b> – To be built back as per the specification for thatch roofs. Roofing over the back extension and new bathroom to be lean-to Victorian profile sheet metal roof with dark grey integrated paint finish.</p> <p><b>Walls</b> – Original clay brick to be stabilized and finished as per the repair specification. New walls and those of existing cement block extensions to be rebuilt in clay masonry.</p> <p><b>Windows</b> – The steel windows are intact and can be repaired.</p> <p><b>Doors</b> – To be timber framed, ledged, braced and battered doors in timber frames. Reinstall timber door to roof loft.</p> <p><b>Pergola/trellis</b> – None – not in evidence, therefore no reconstruction necessary.</p> <p><b>Retaining/steep walls</b> – The existing stoep and terrace walls are to be preserved and repaired where required.</p> <p><b>Chimney</b> – rebuild chimney to generic specification – check gable wall for position and form.</p>

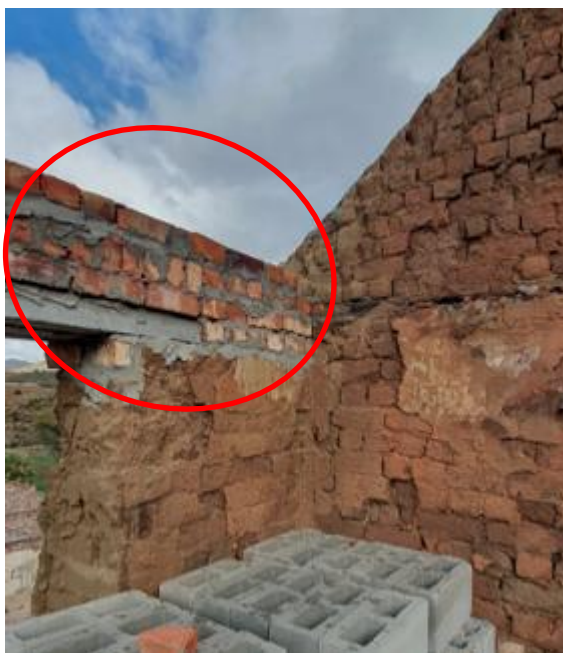
Fig 18 – Raised side walls  
(supplied by author)

These transgressions mainly related to raising the side walls of the houses to gain additional internal height. The walls were built up to the gable acroteria which meant there was no remaining space for a parapet at the gable ends (Fig 18). This in turn led to gables being broken down or being sheeted over to accommodate the new finished roof level (Figs 19 and 20). In other instances the gables had been raised. (Fig 21) . The gables are a prominent part of the streetscape and were nearly all intact after the fire. Fortunately, much of this work was halted by HWC and the Church before roofing commenced and before further damage could be caused to the gables.

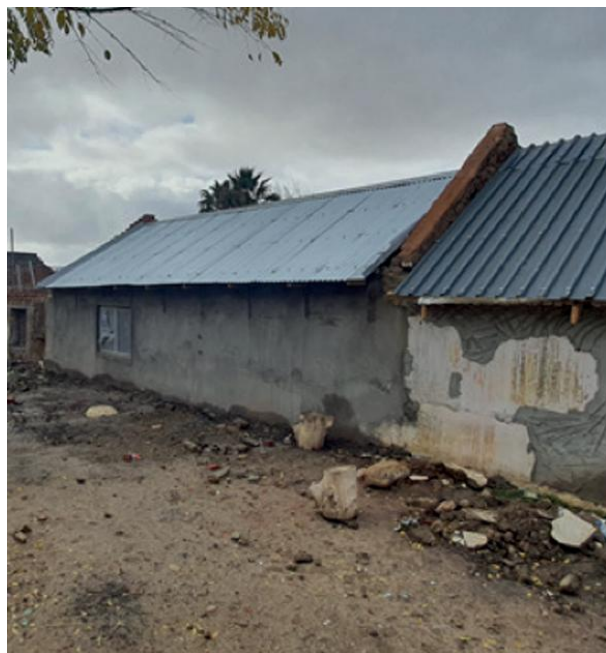
Fig 19 – Consequence of raising side walls  
(supplied by author)

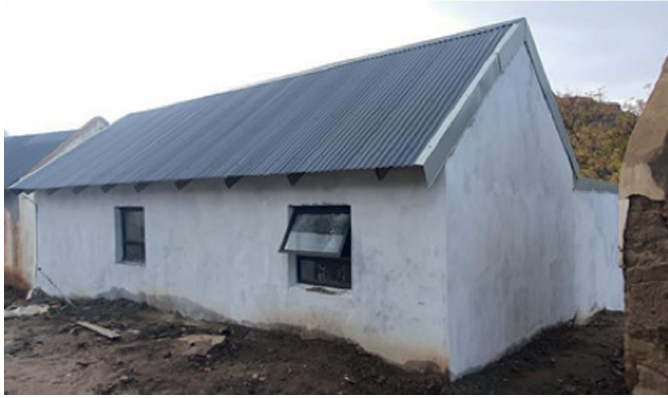
Fig 20 – Side walls raised and gables covered over (supplied by author)

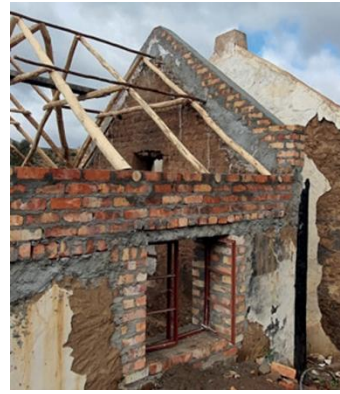
Fig 21 - Gables raised. (supplied by author)

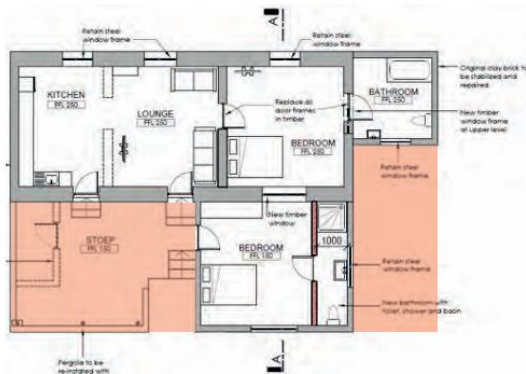
Fig 5 Plan showing additions to the approved floor plan in red

Of extreme concern was the rebuilding of 7 Tra Tra Street where the wide street side stoep had been incorporated into the house and additional area had been added to the north east side by building into the side lane, all of which was now under a single roof covering the entirety. The old building form or gables were no longer visible. This house remains an over scaled concerning disruption in the middle of Tra Tra Street at the time of writing (Fig 22)

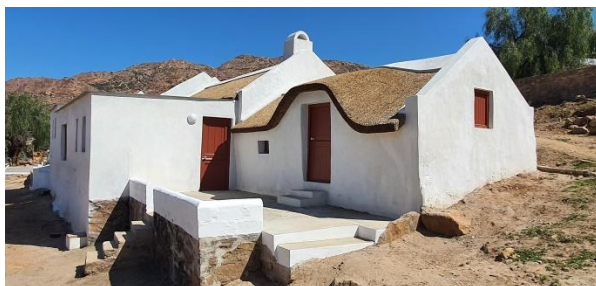
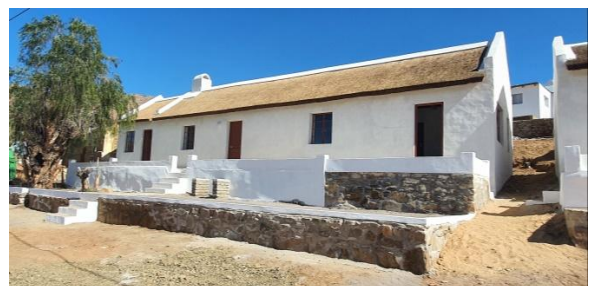
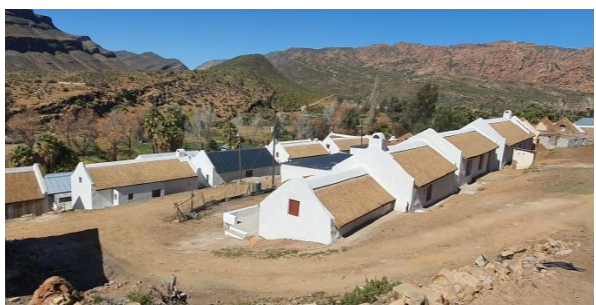
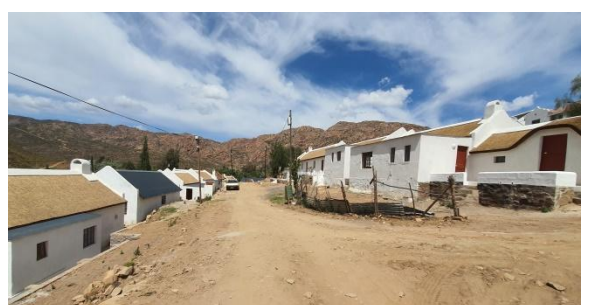
Fig 23 Completed buildings

The houses were all originally constructed of similar sundried clay bricks with daga mortar and plaster, some with stone riser walls especially at the rear of the house where the walls retained the road that was at a higher level than the floor of the house. Out buildings or additions were under "afdak" roofs and their walls were generally of cement brick or block. All of these cement based walls cracked badly

during the fire and the initial structural engineer's report advised demolition. This was done and new clay brick walls were constructed in their place. It was recognised early on during the CIFA work that bargeboards and downpipes should not be included on the afdaks and it is interesting to see the very negative impact that such sensible and seemingly innocuous elements have on the streetscape where they have been installed on some of the transgression houses.

The sundried brick walls withstood the fire well, and it was damage from two winters of exposure that impacted most on these walls. The top of the walls were therefore worst affected and rebuilding was undertaken with old or weathered clay brick, not fresh bricks, to avoid differential movement through expansion. Lime mortar was also used, as well as lime plaster which is far more suitable on the soft brick than a hard cement plaster, which delaminates over time and has no breathability, trapping moisture in the walls and causing eventual failure.

Poplar poles were harvested from Wupperthal and surrounds using local labour and the builder's transport. Stripping the bark off the poles would have been an expensive and time consuming exercise, so poles were used with the bark on. It was found that the donkeys of Wupperthal were partial to the bark, but there were too many poles and too few donkeys for them to be gainfully employed in bark stripping.
