VASSA Journal

The rescue restoration of the historic town centre of Wupperthal Mission Station Cederberg,

South Africa, 2019-2021 | Graham Jacobs

Rebuilding homes after the fire of 2018 | John Wilson-Harris

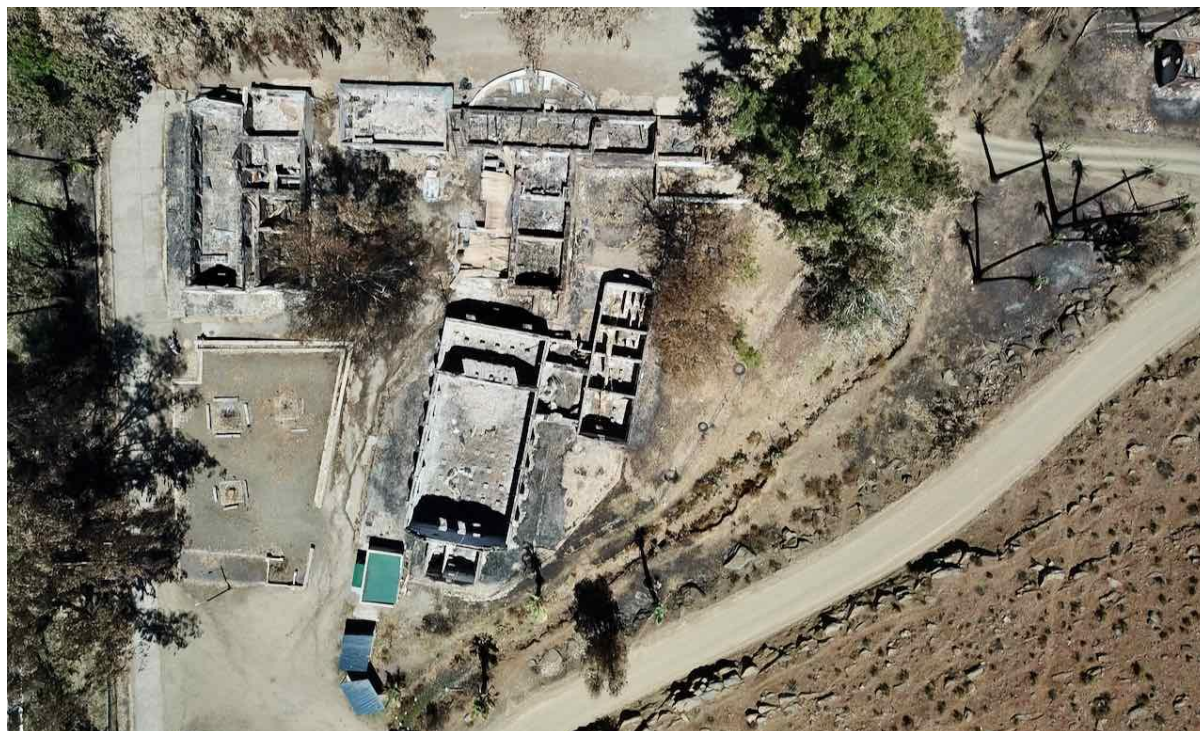
Figure 1: Aerial view showing the gutted state of some of the buildings in the town centre after the fire. Top centre are the remains of Leipoldt House with its T-shaped plan and semicircular stoep. To the left are the remains of the old Mission Stores building, the first school building in the settlement. Below are the remains of the Community Hall. The Old Blacksmith's Shop (Smitswinkel) where wagon wheels were repaired after a torturous trip down the mountain pass is just visible on the extreme upper right. The latter was the first building to be gutted in the fire. The road on the bottom right enters Wupperthal from the pass. (Drone image: Goal Zero Consulting)

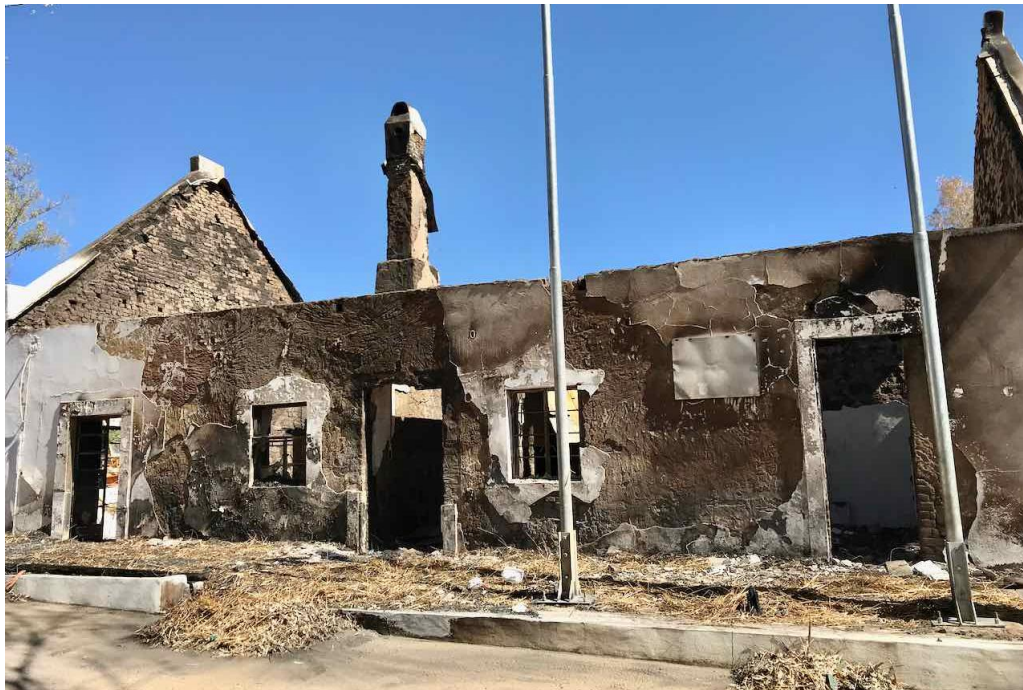
Figure 3: The fire-gutted 'Winkelhuis' (Shopkeeper's House) after the fire. The building had been the administration headquarters for the town before the fire. This image is typical of the degree of damage sustained. (Image: ARCON, 24 January 2019)

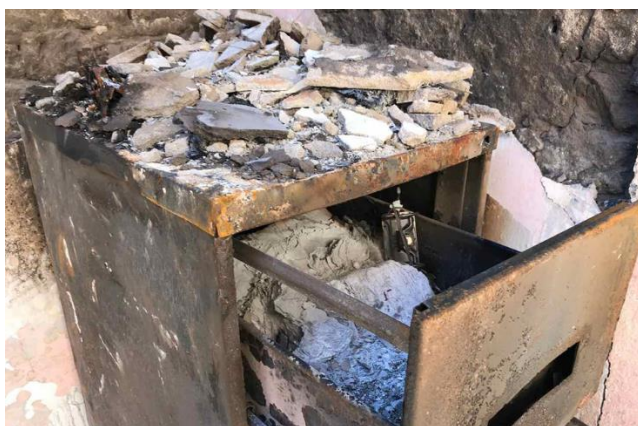
Figure 4: Most of the town's records were lost in the fire. That included drawings, photographs, title deeds, survey diagrams and other historic and historical records that would otherwise have been useful for informing the reconstruction process. (Image: ARCON, 24 January 2019)

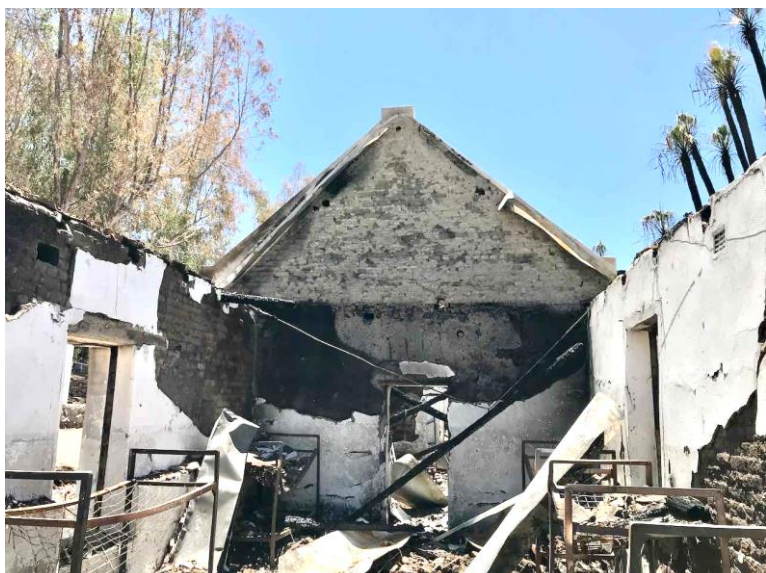
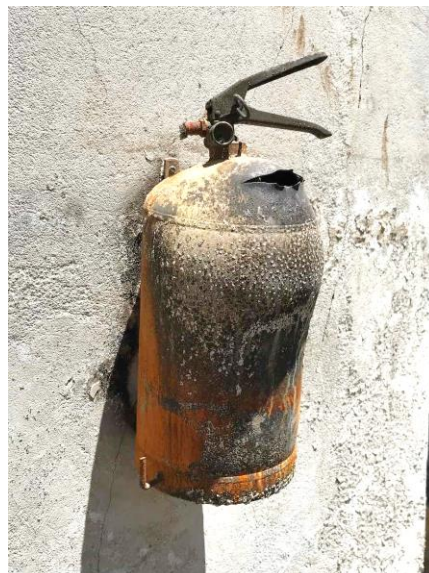
Figure 5: Left: One of the gutted school hostels littered with mangled bed frames and building debris.

Right: The fire spread so rapidly that the fire extinguishers could not be used. This example was left to explode on its wall bracket. (Image: ARCON, 24 January 2019)

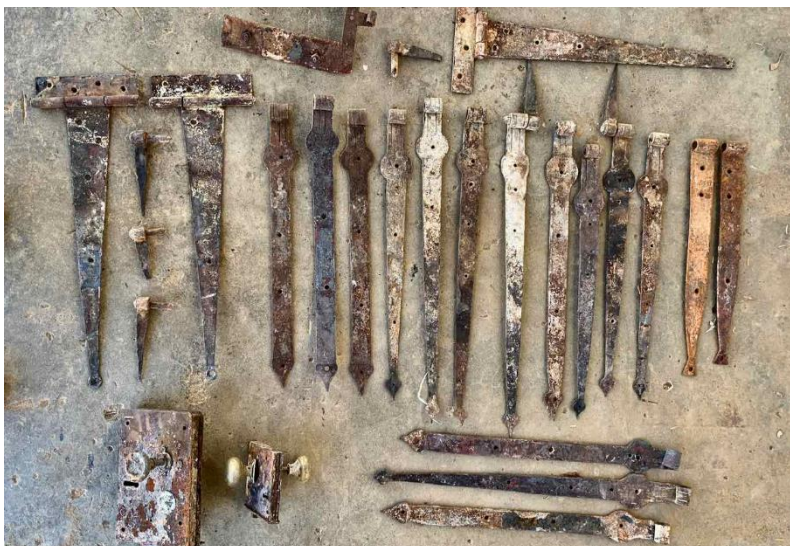
Figure 7: Examples of historic ironmongery recovered after the fire. These included a large 19th C front door lock (bottom left). Most were recovered from the ashes and rubble of the Winkelhuis; and most, including the badly damaged and heat-seized door locks, were reconditioned and reinstalled during the restoration project. (Image: ARCON, 24 January 2019)

- iv. *Re-use of Surviving Historic Elements:* Wherever sound surviving fittings and/or other materials were recovered, these were relocated in their a-found positions or as close to those as possible.

- v. *Salvaging Surviving Historic Elements Unfit for Re-Use:* Where historic elements were too badly damaged for re-use, they were retained in safe storage as relics for future inclusion as displays in the museum planned for Leipoldt House after its restoration.

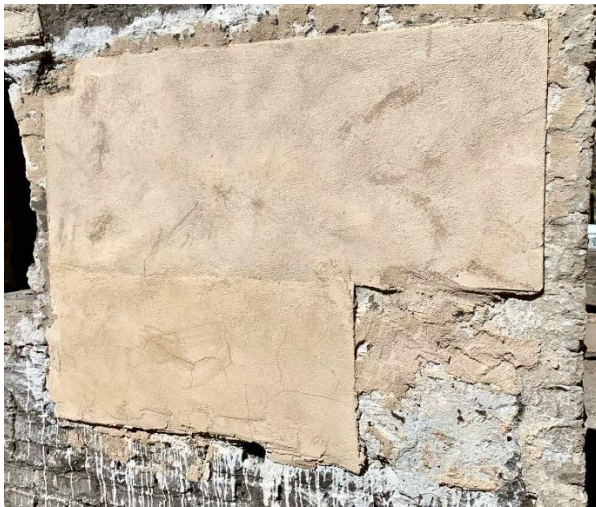
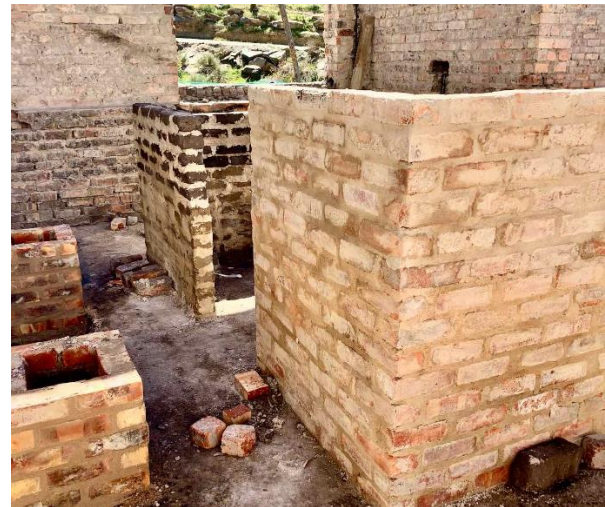
Figure 8: Trial panels using lime/sand mixes for plastering and laying brickwork. Left: Two separate lime plaster panels experimenting with water proportions. The shrinkage cracks in the lower panel show that too much water was added. Right: Trial samples of brick walls constructed using exclusively lime/sand mortars to convince an initially sceptical contractor that such lime mortars without Portland cement would be structurally sound. The wall in the foreground is constructed using modern fired bricks. The darker wall in the background experiments with bricks recovered from the fire damaged ruins. (Image ARCON, 30 August 2019)

Another conscious decision was to use only lime mortars, plasters and renders in the reconstruction project (no Portland cement added to the mix whatsoever), with the exception of new foundations and floor slabs. In those latter instances, the inclusion of Portland cement was permitted but subject to the contractor keeping a log of when and where cement was used. The cement was also stored separately from the stockpiles of builder's lime. The underlying principle was that newly introduced material had to be as physically compatible with the old traditionally constructed fabric as possible. Builder's lime, being able to accommodate considerably more movement than Portland cement, having superior adhesion properties to softer clay mortars and old brickwork, and being more permeable to water vapour, was therefore the obvious choice over Portland cement.

The contract had a special condition that pan mixers were to be used for the mixing of lime/sand mortars and renders. That was to ensure that the ingredients would be properly mixed to avoid possible future adhesion problems and weak spots. Improperly mixed and poorly prepared and cured lime mortars and renders have been one of the main problems behind the unfair reputation that lime products have acquired in the construction industry in South Africa. One unexpected drawback of using lime was discovering during the first winter months when temperatures in the Cederberg occasionally plunged to below freezing point. Lime stops hardening below 5°C which consequently did slow operations during the coldest days. From then onwards, the contractor was instructed to keep a maximum/minimum thermometer in the site office and daily temperatures were recorded and included in the contractor's monthly reports.

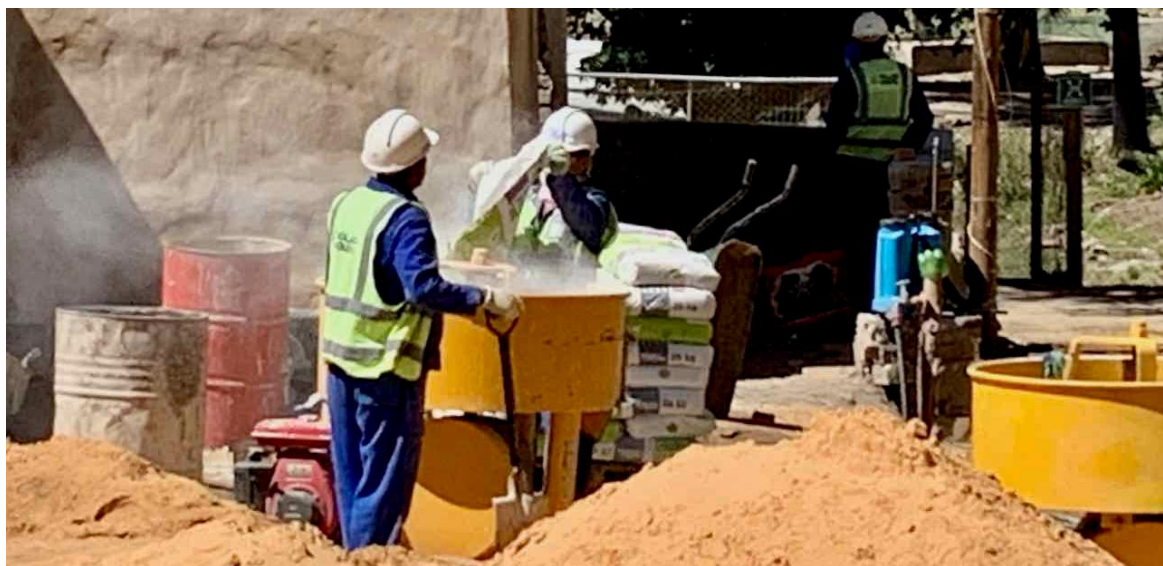
Figure 9: Pan mixers in action preparing lime/sand mortars and renders. The sand used was Malmesbury sand which is coarser and therefore preferred over finer Cape Flats silica sands for work on historic buildings. (Image: ARCON, 25 October 2019)

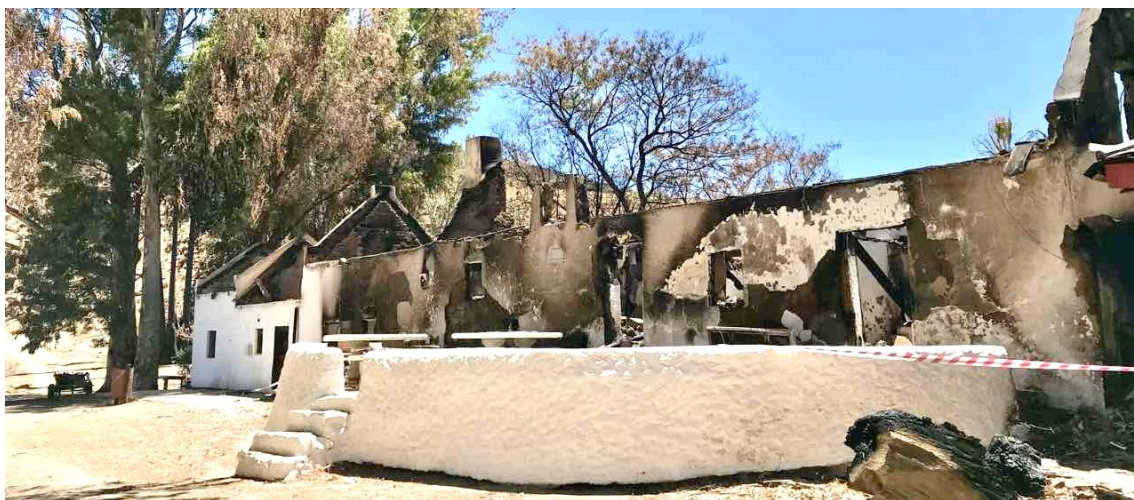
Figure 10A: : Exterior of Leipoldt House after the fire. This building is most probably the original Rietmond farmhouse, pre-dating the arrival of the Rhenish missionaries by about 30 years. The uncharacteristic semicircular stoep appears to have been used as a podium from which open-air services were conducted before the church was completed, explaining its non-traditional shape. (Image: ARCON, 25 October 2019)

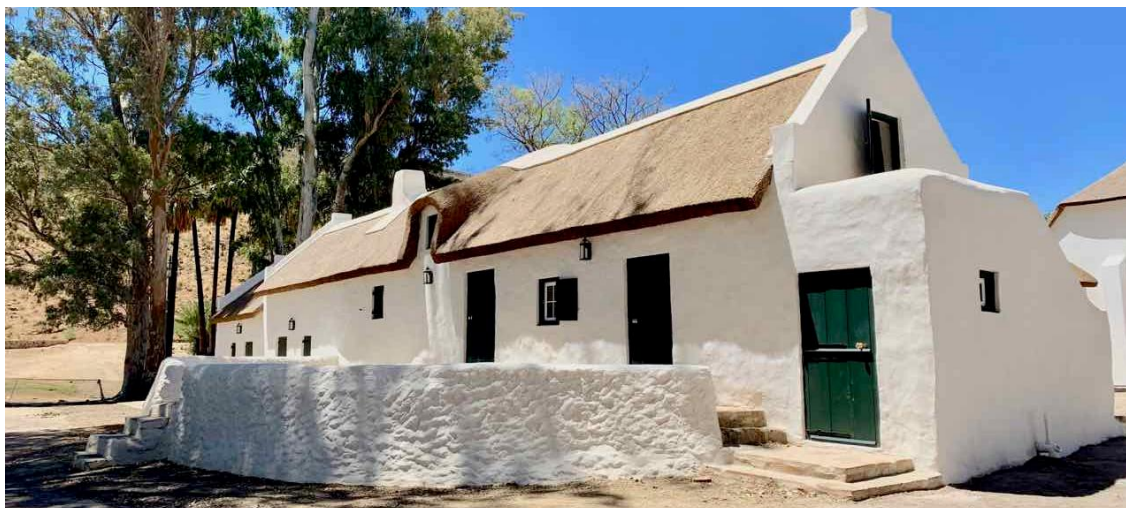
Figure 10B: : Exterior of Leipoldt House after restoration. (Image: ARCON, 27 Nov 2020)

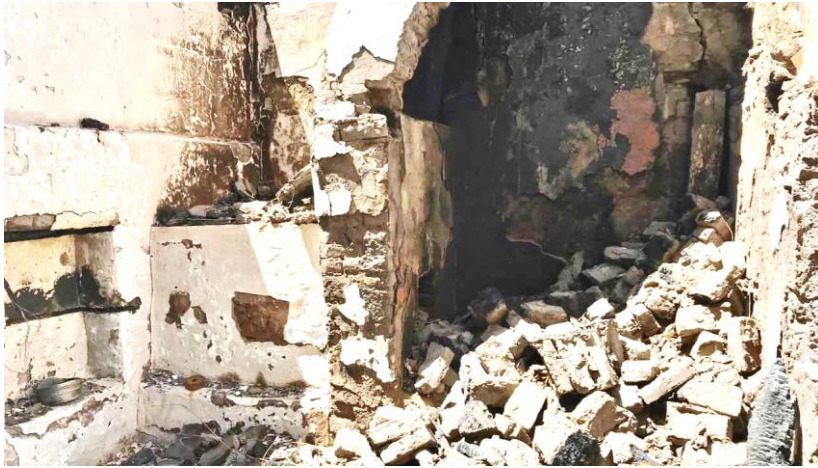
Figure 10C: The kitchen hearth of Leipoldt House after the fire which collapsed.

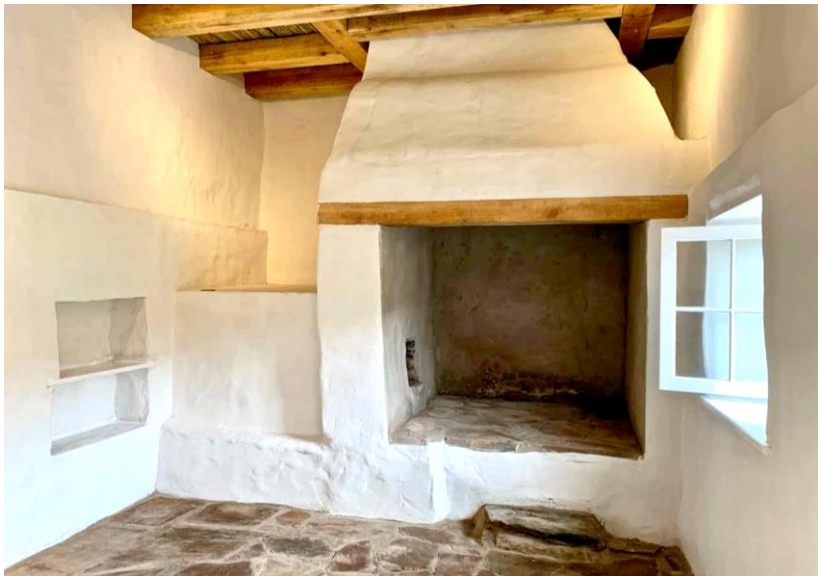
Figure 10D: The kitchen of Leipoldt House after restoration and reconstruction of the hearth flue. (Image: ARCON, 1 September 2020)

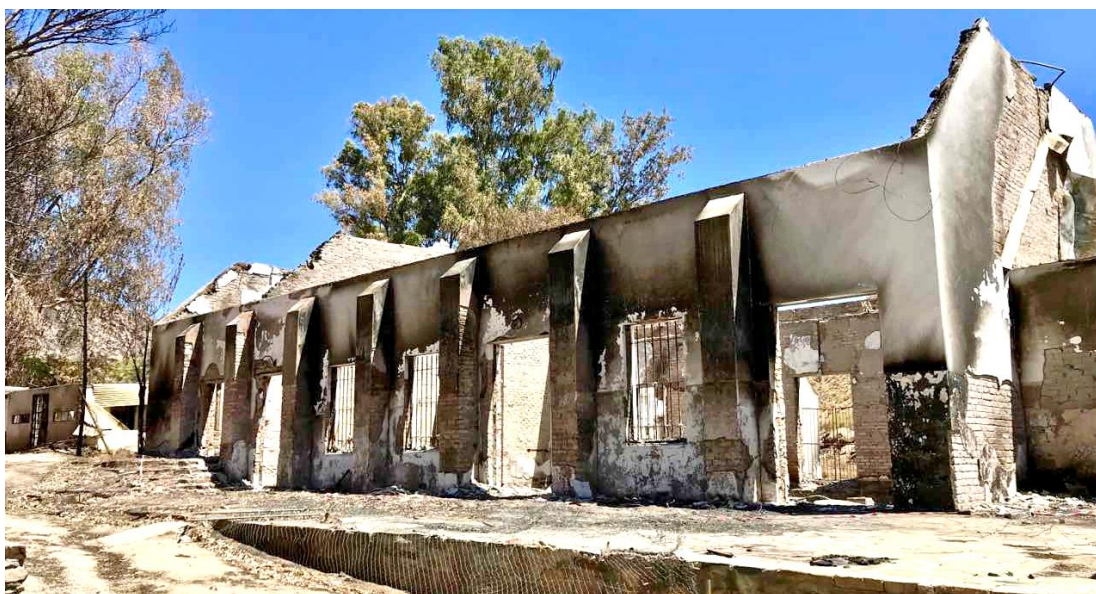
Figure 11A: : Exterior of the Community Hall after the fire. (Image: ARCON, 24 January 2019)

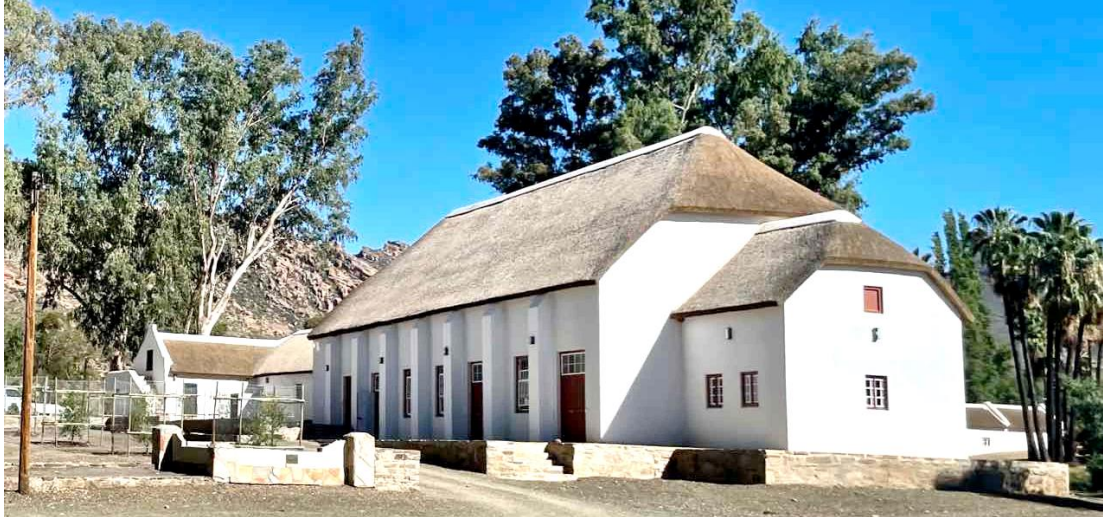
Figure 11B: : Exterior of the Community Hall after restoration. The small addition in the foreground replaces an earlier cement brick addition that stored the brass band's instruments and suffered bad structural cracking in the fire. It had to be totally reconstructed because of the damage sustained to its cement brick walls. The walls and buttresses of the main hall were able to be retained. The building is relatively recent, having been constructed in 1980. It was designed by renowned architects Revel Fox & Pnrs. (Image: ARCON, 8 June 2021)

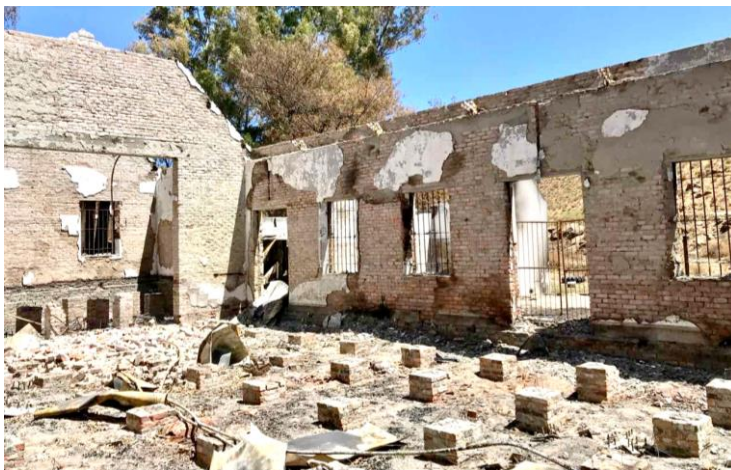
Figure 11C: Gutted interior of the Community Hall after the fire. (Image: ARCON, 24 January 2019)

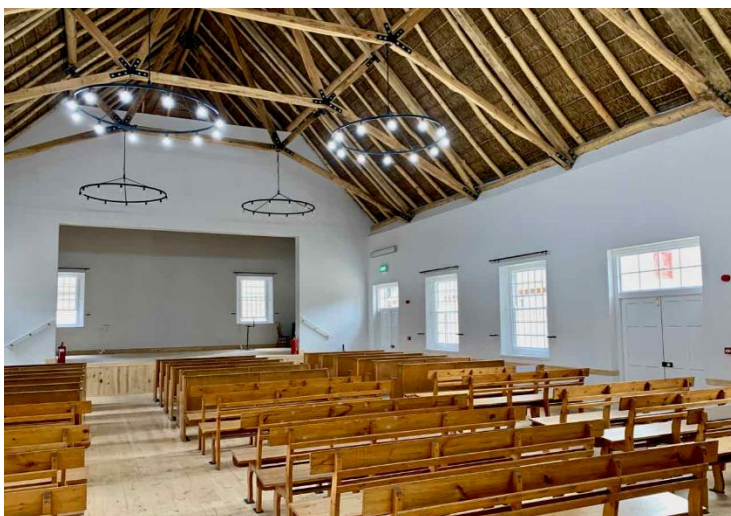
Figure 11D: The interior of the Community Hall after restoration was practically complete. The roof trusses are a more rustic re-design of the destroyed originals, which had been made of uniformly turned members. The simple chandeliers were specially designed for the interior. (Image: ARCON, 9 July 2020)

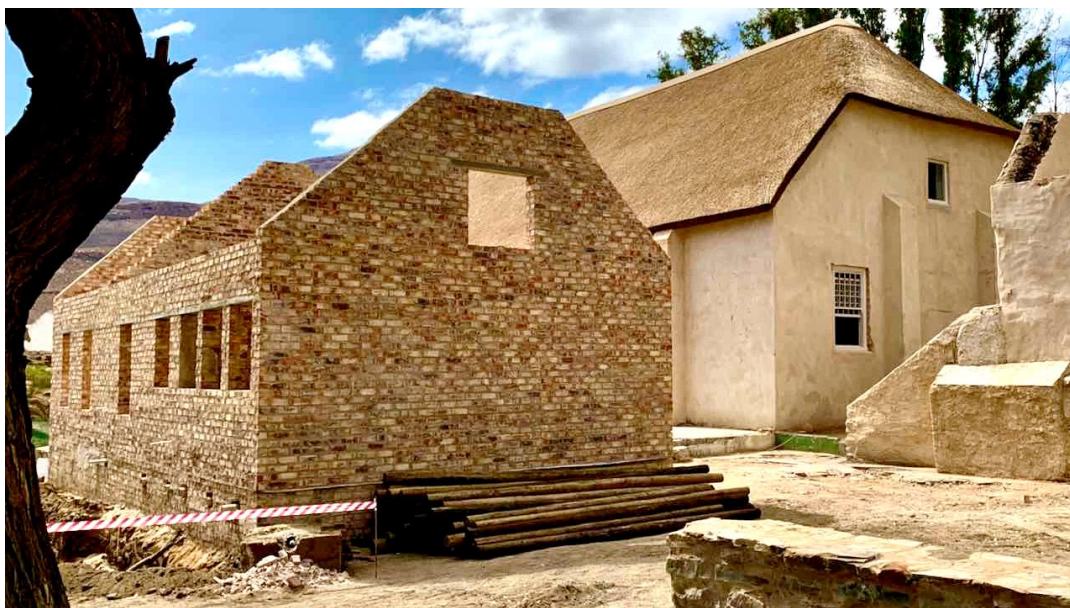
Figure 12A: The Creche Building under reconstruction (left) to accommodate new toilets and office space for the Community Hall. (Image: ARCON, 21 January 2020)

The Creche building, constructed in c.1980 with the Community Hall, was so badly damaged by the fire that the remains had to be demolished down to foundation level. The Moravian Church then decided to relocate the creche and requested that the building be reconstructed to accommodate new toilets and an office for the restored hall.

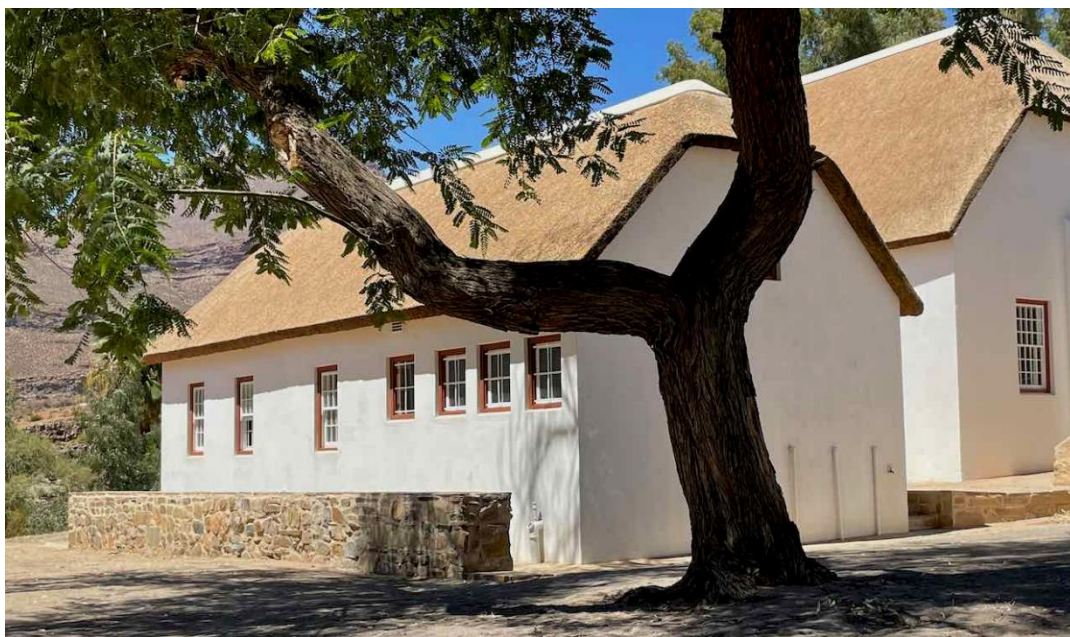
Figure 12B: The Creche Building under reconstruction (left) to accommodate new toilets and office space for the Community Hall. (Image: ARCON, 21 January 2020)

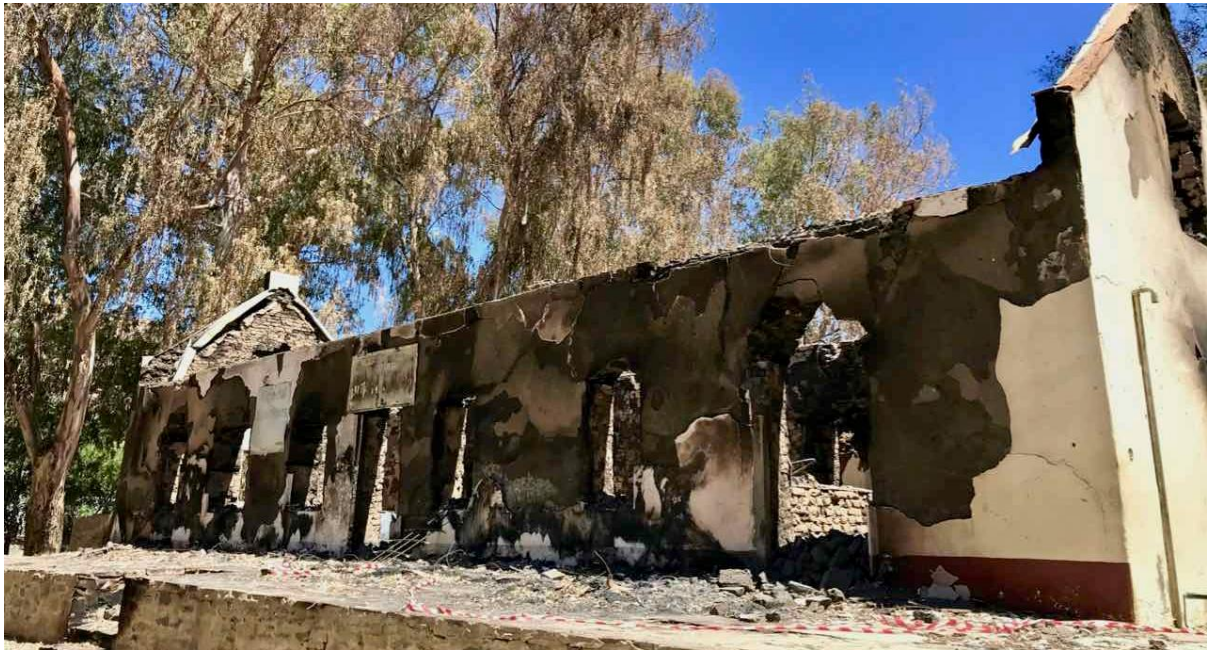
Figure 13A: The Mission Stores Building after the fire. (Image: ARCON, 24 January 2019)

The Mission Stores, one of the oldest buildings constructed or enlarged by the Rhenish missionaries, originally housed the first school in Wupperthal. Fransen records the building as having sash windows stylistically dating back to c.1830 with much internal timberwork of the same period. All of this was, most unfortunately, lost in the fire. At the request of the Moravian Church, it was decided to restore the building to include a restaurant and kitchen as an opportunity for promoting local business and job creation.

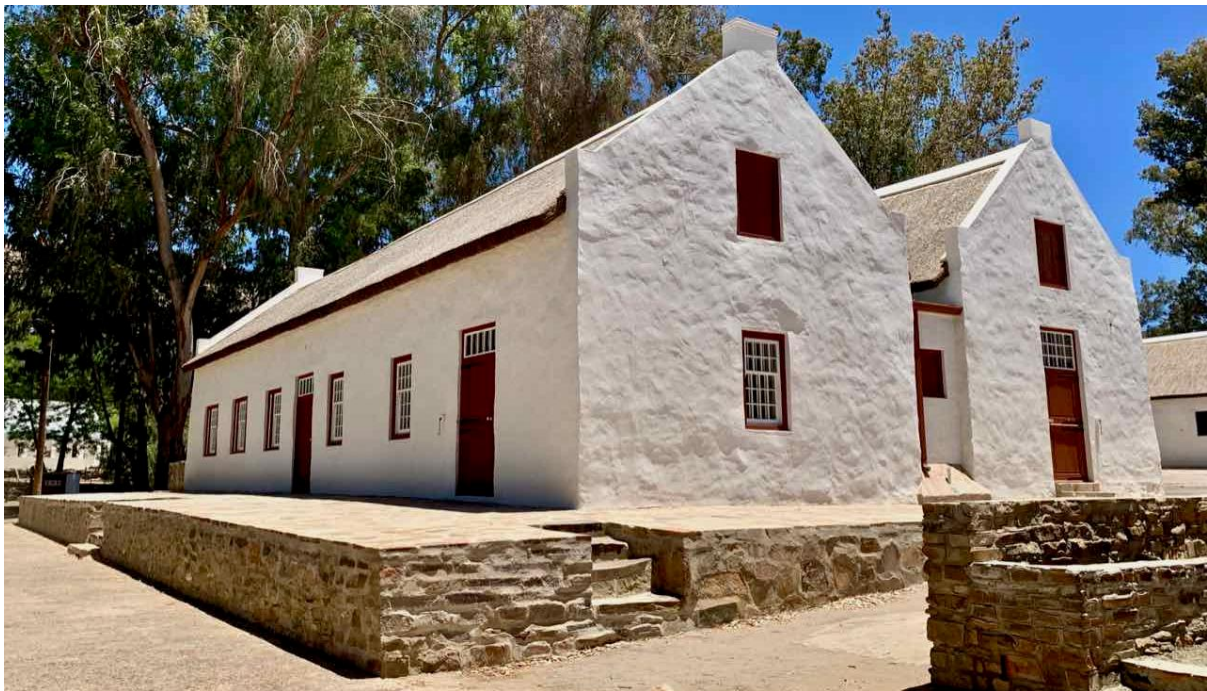
Figure 13B: The Mission Stores Building restored to include a restaurant and catering kitchen. (Image: ARCON, 9 March 2021)

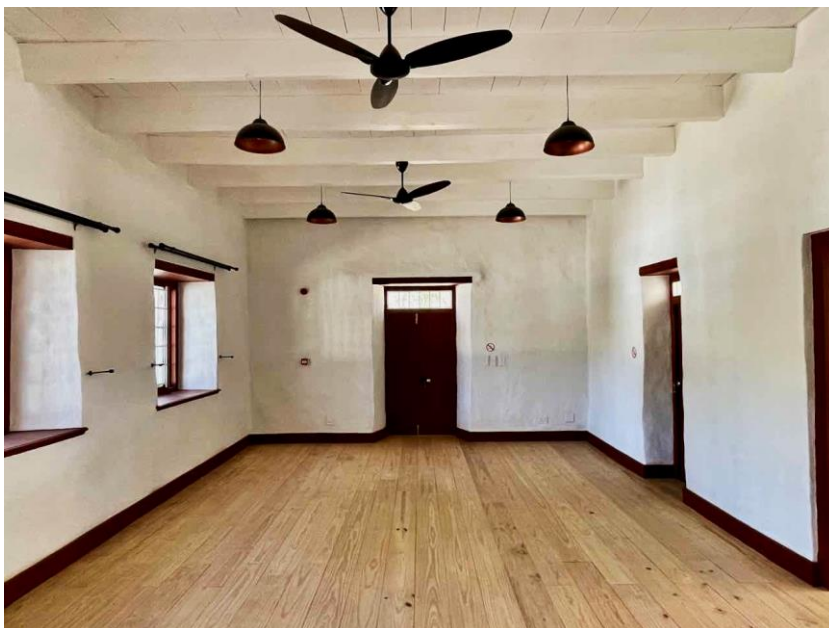
Figure 13C: Part of the Mission Stores interior after the fire. (Image: ARCON, 9 March 2021)

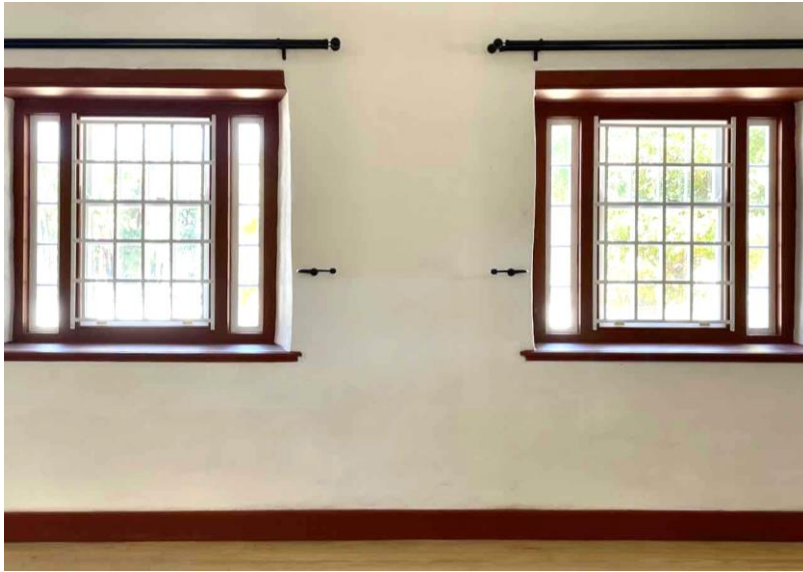
Figure 13E: Example of old wrought iron strap hinges recovered after the fire, refurbished and reinstalled in the Mission Stores building. (Image: ARCON, 7 April 2021)

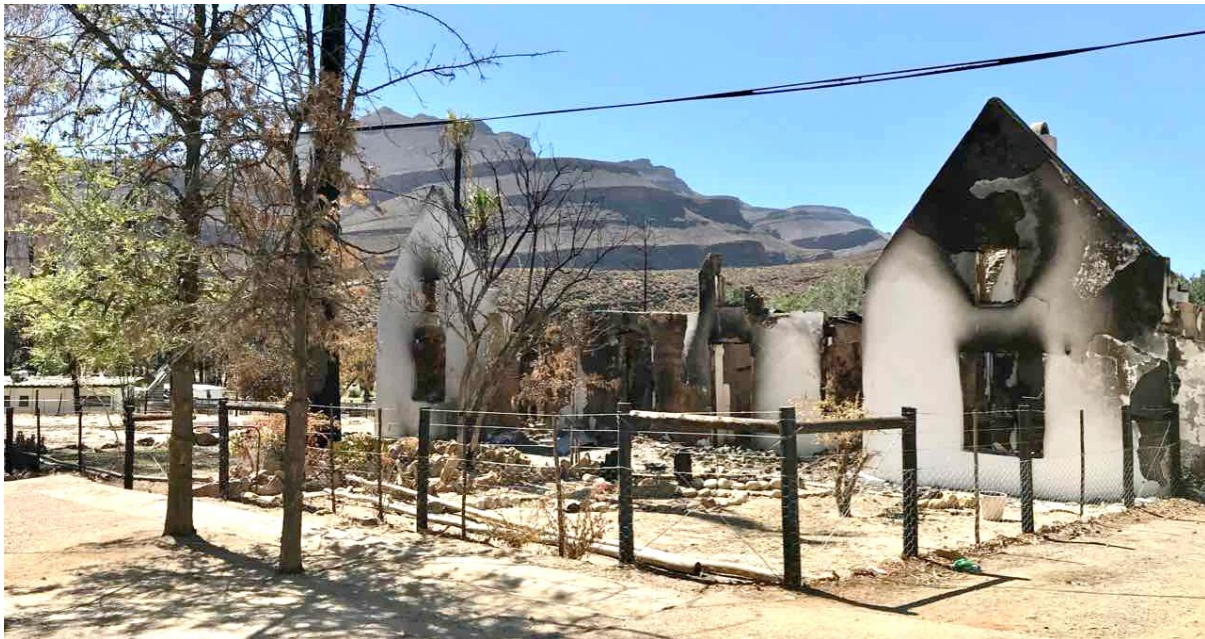
Figure 14A: The Parsonage after the fire. (Image: ARCON, 24 January 2019)

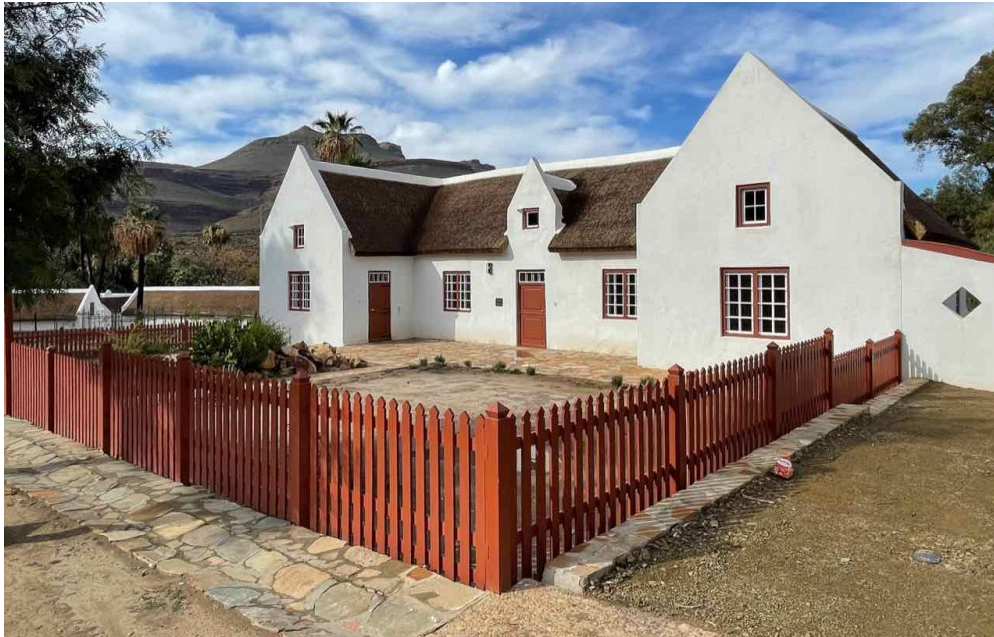
Figure 14B: The Parsonage after restoration. The palisade fence was copied from remains that survived the fire in front of the Winkelhuis opposite. (Image: ARCON, 8 June 2021)

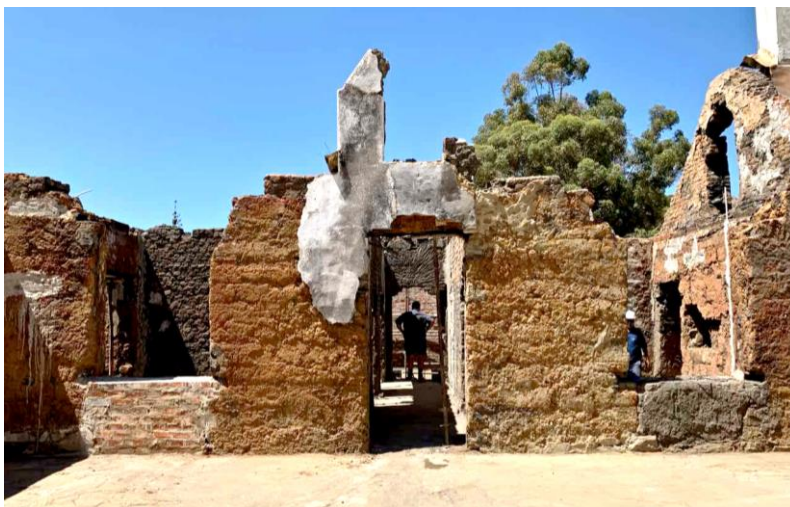
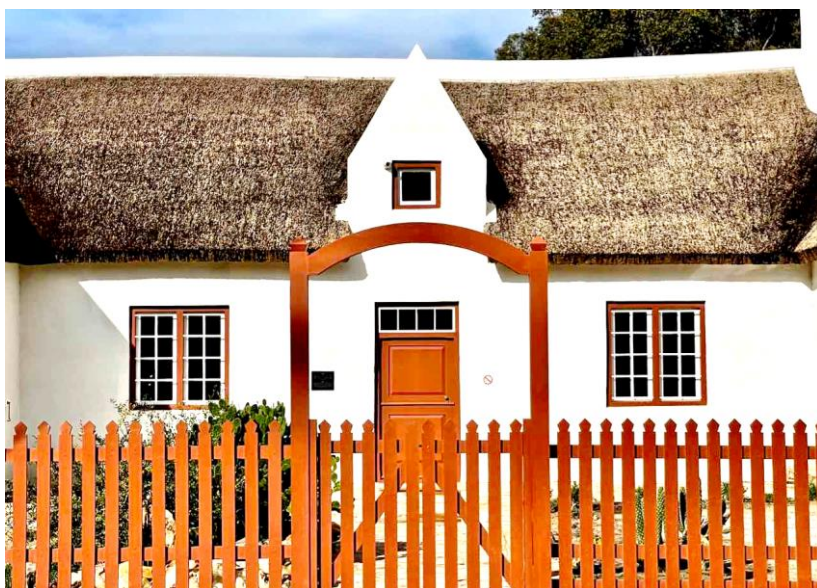
Figure 14C: The front façade of the Parsonage after the fire debris had been cleared. The rammed earth construction of the central portion of the facade is clearly evident in the horizontal wall striations. (Image: ARCON, 30 January 2020)

The date of construction of the parsonage is not clear but appears to have been built shortly after 1845. Rev. Gottlieb Leipoldt would probably have used this building as his residence after Leipoldt House. It appears to have been constructed in two stages, the earlier central portion using rammed earth (an old pioneer construction technique) with flanking wings constructed of bricks, added later.

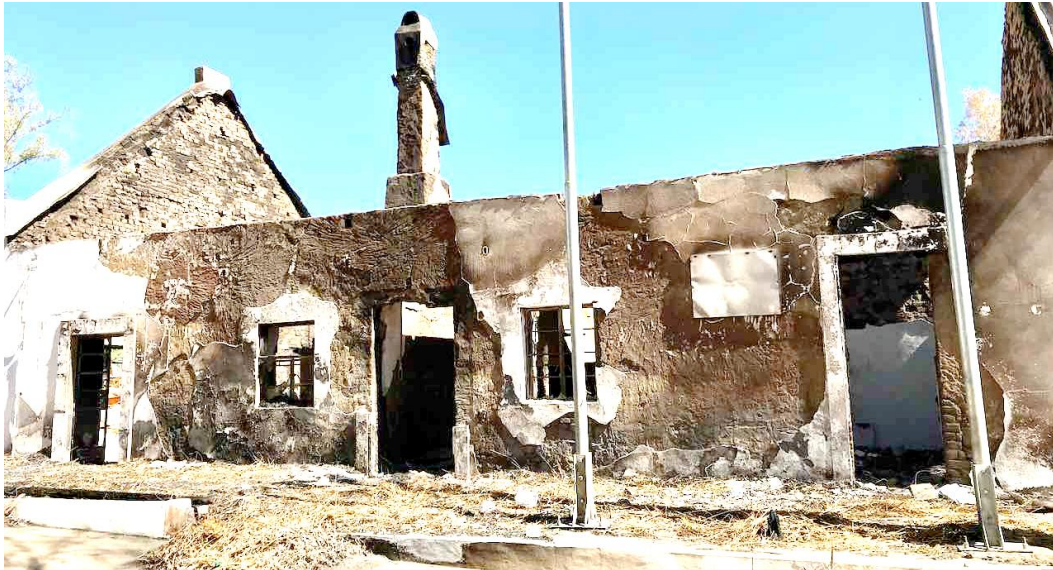
Figure 15A: The front façade of the Winkelhuis after the fire. This was one of the buildings initially considered particularly dangerous with various large wall cracks. However, on closer examination, it was found that the cracks pre-dated the fire. (Image: ARCON, 23 March 2021)

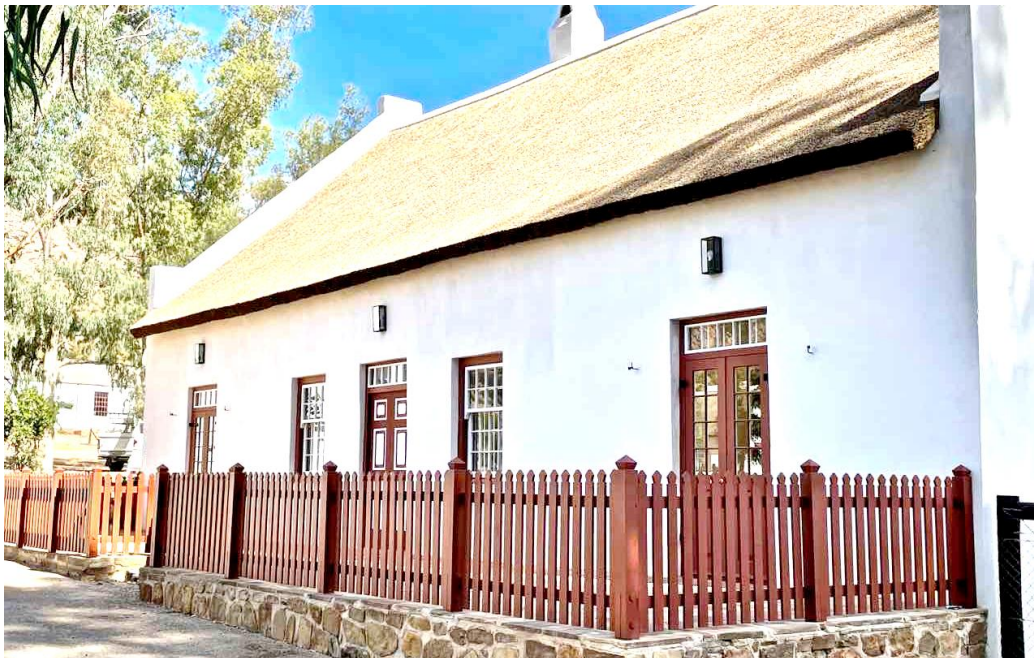
Figure 15B: The Winkelhuis front façade after restoration. (Image: ARCON, 9 March 2021)

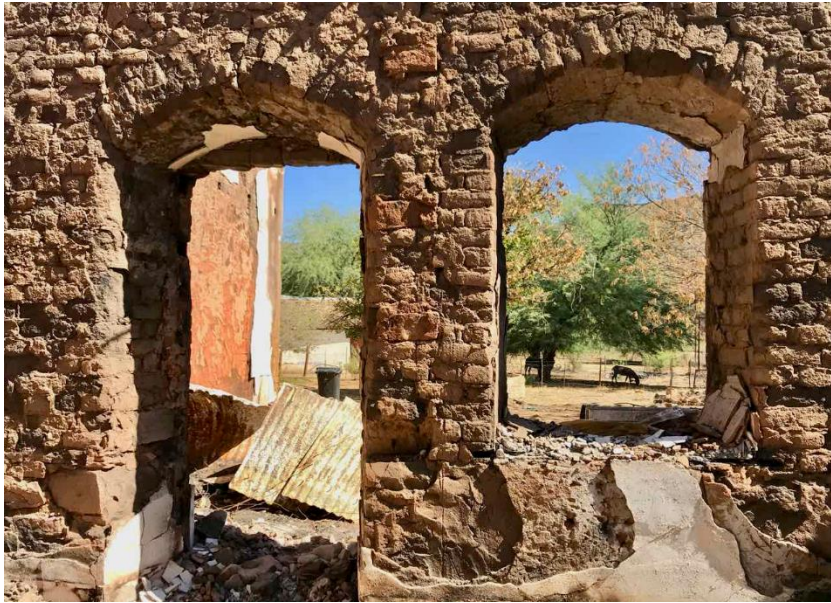
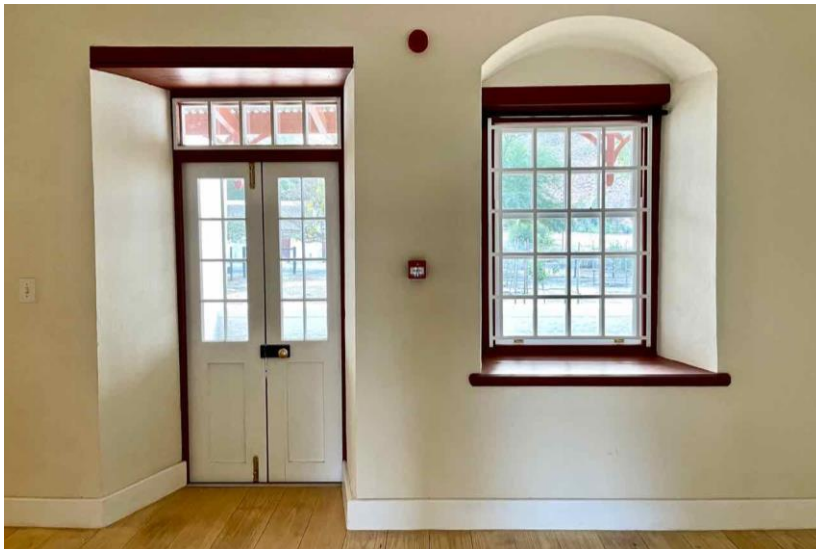
Figure 15C: From the lounge interior of the Winkelhuis looking through to the back garden after the fire. (Image: ARCON, 24 January 2019)

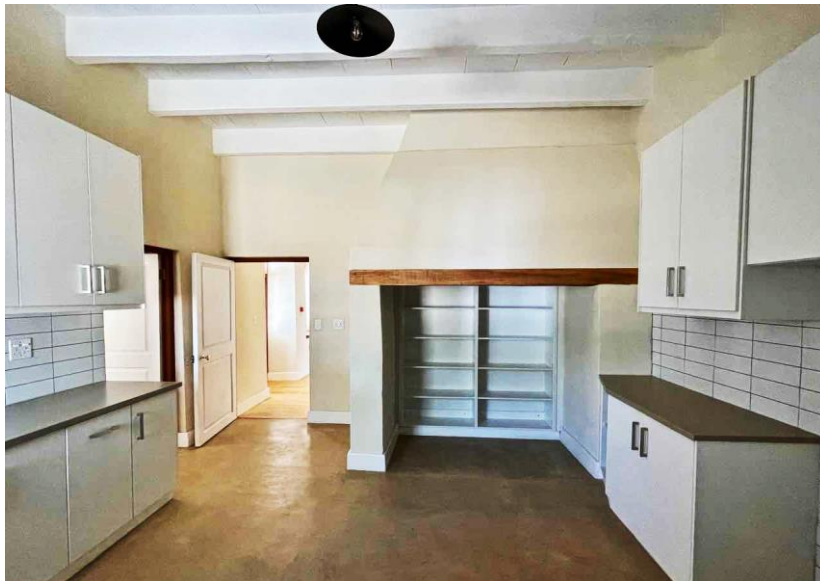
Figure 15E: Collapsed kitchen hearth in the Winkelhuis after the fire. All intact bricks were recovered and re-used in its reconstruction. (Image: ARCON, 24 January 2019)

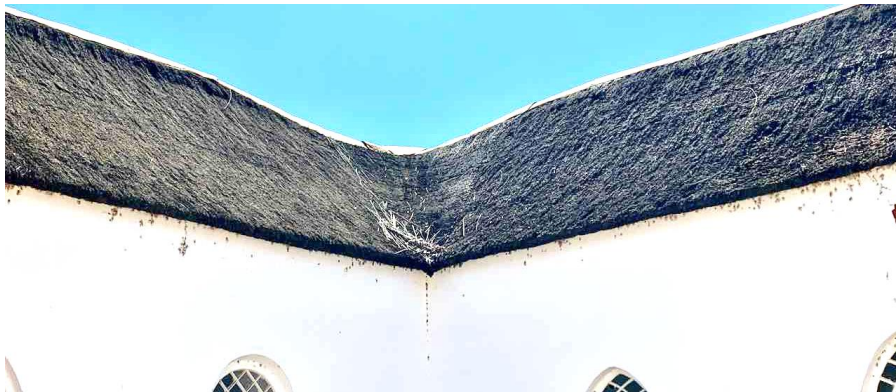
Figure 16A: View of the thatch roof of the church before reconstruction. The roof was in very poor condition and in a state of near collapse between nave and transept. (Image: ARCON, 1 Nov. 2019)

The church building, inaugurated in 1835 by the Rhenish missionaries, was found to have a structurally poor roof. The Foundation therefore generously decided to broaden the project brief, leading to the entire re-roofing of the building despite it not having sustained fire damage. Carpenter's marks on one of the ceiling ribs (Figure 16C) show the ceiling to have been a later addition. It was found that the original installation had involved the cutting away of diagonal trusses between the nave and transept, presumably because those trusses would have extended below the new vault line. That resulted in a badly weakened roof at the intersection between nave and transept and was on the point of collapse. The roof consequently had to be strengthened with new trusses placed between the old, effectively becoming a new roof structure. The building was then fully re-thatched.

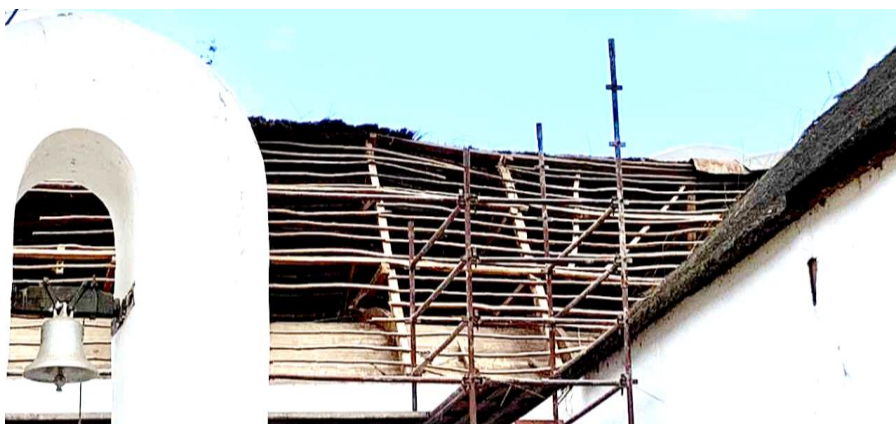
Figure 16B: The roof with thatch removed showing the very poor condition of the roof timbers. (Image: ARCON, 1 Nov. 2019)

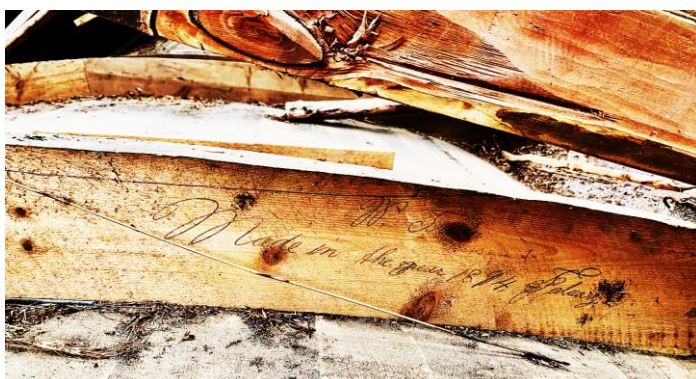
Figure 16C: Carpenter's signature on one of the saucer vault ribs record that the ceiling was added in 1894. This practice has been revived at Leipoldt House and other new joinery forming part of the restoration process (Figure 10F). (Image: ARCON, 1 Nov. 2019)

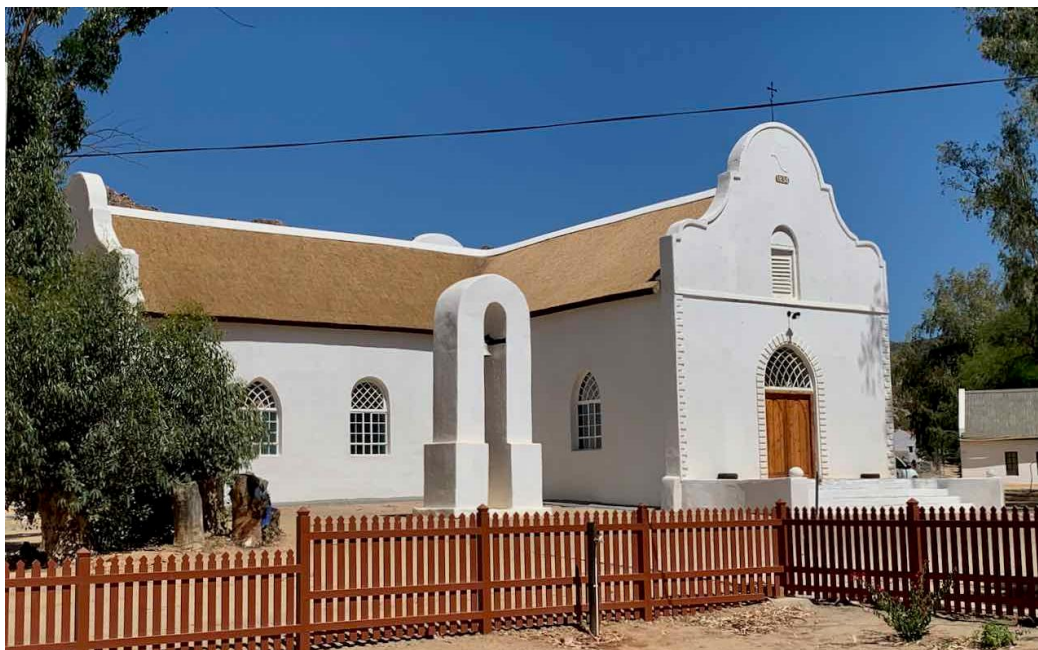
Figure 16F: The church building after completion of the new roof and repainting with a propriety breathable wall coating. (Image: ARCON, 14 January 2021)

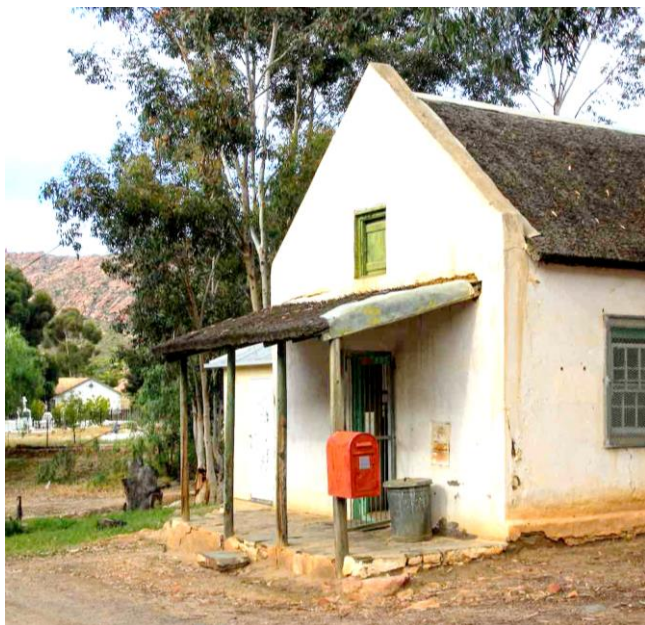
The date of the Post Office building is not known but suspected to date back to the earlier half of the 20th C. The building was left almost completely undamaged by the fire apart from its thatched front entrance canopy which had totally burned away. Fortunately, the main thatch roof had not caught fire. The building was, however, in need of maintenance. That included requiring attention to extensive cracks in its walls. It was therefore decided to repair the cracks, repaint the building and construct a new canopy. This new canopy is a smaller cantilevered corrugated iron roofed structure and not thatch. Another thatch version would have deteriorated faster, considering its shallow pitch.
