VASSA Journal

The rescue restoration of the historic town centre of Wupperthal Mission Station Cederberg,

South Africa, 2019-2021 | Graham Jacobs

Rebuilding homes after the fire of 2018 | John Wilson-Harris

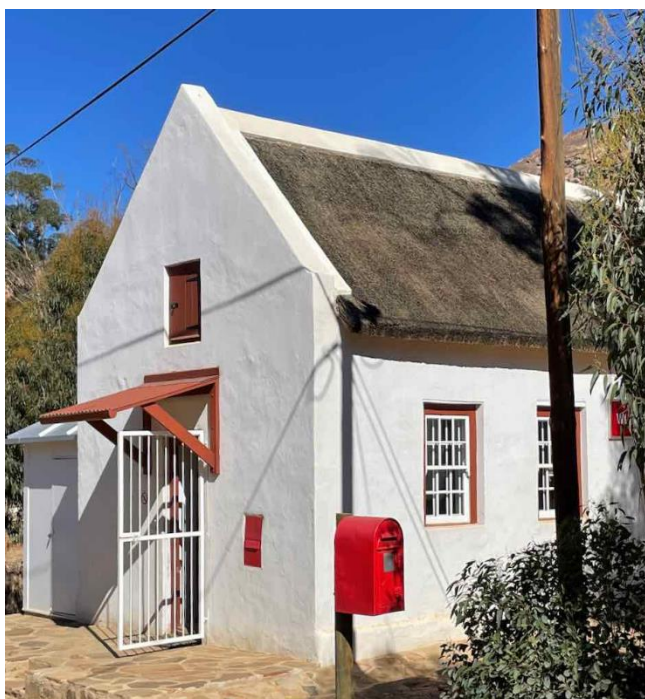
Figure 17B: The Post Office Building after refurbishment including new paving on the front stoep using locally sourced sandstone laid by local labour. A smaller corrugated iron front entrance canopy replaced the previous burned-out thatch canopy which had too shallow a pitch to withstand protracted weathering.
(Image: ARCON, 18 May 2021)

The date of the Post Office building is not known but suspected to date back to the earlier half of the 20th C. The building was left almost completely undamaged by the fire apart from its thatched front entrance canopy which had totally burned away. Fortunately, the main thatch roof had not caught fire. The building was, however, in need of maintenance. That included requiring attention to extensive cracks in its walls. It was therefore decided to repair the cracks, repaint the building and construct a new canopy. This new canopy is a smaller cantilevered corrugated iron roofed structure and not thatch. Another thatch version would have deteriorated faster, considering its shallow pitch.

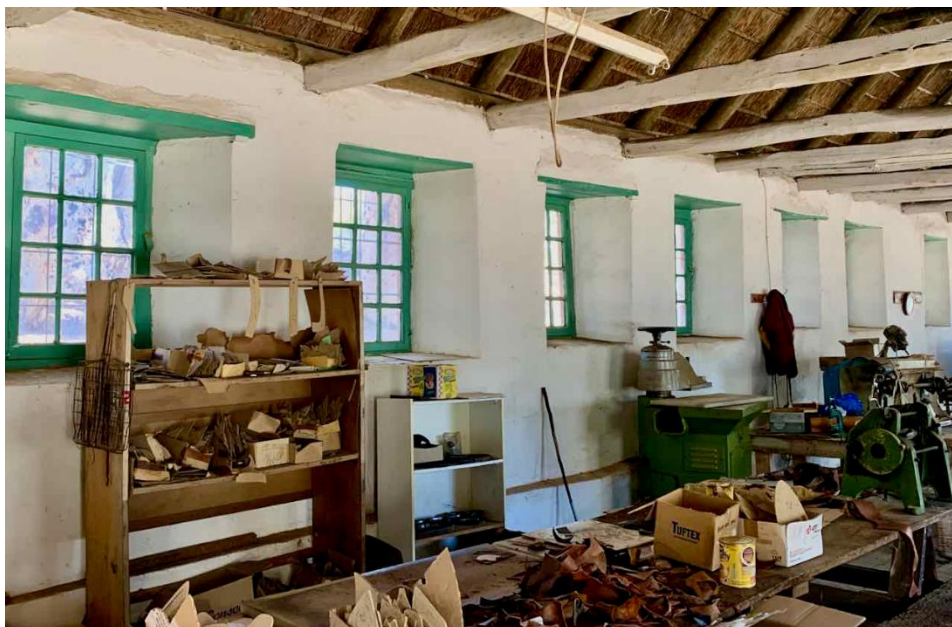
Figure 18A: Interior of the Shoe Factory before refurbishment with surviving original casement windows; now in all likelihood the oldest surviving casement windows in the settlement since the fire. (Image: ARCON, 17 March 2020)

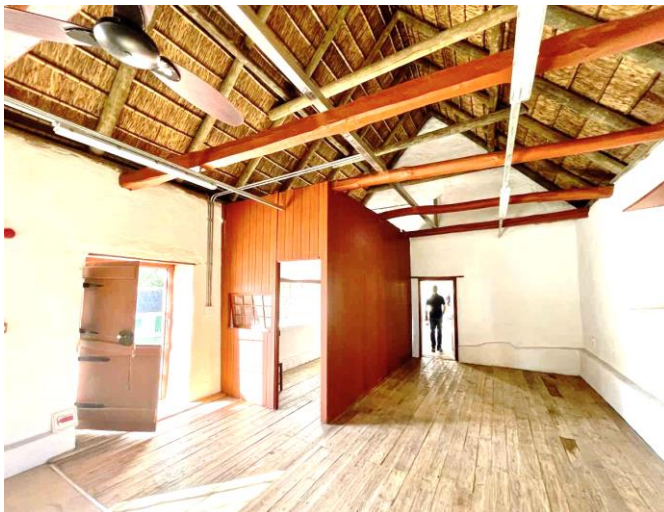
Figure 18C: Interior of the Shoe Factory after refurbishment. The floor had to be entirely re-laid, but using planks cleaned and recycled from the old floor. There was a conscious effort to retain as much of the floor's worn, rustic quality as possible. New lighting, fans, workstations and electrical systems were added. (Image: ARCON, 4 May 2021)

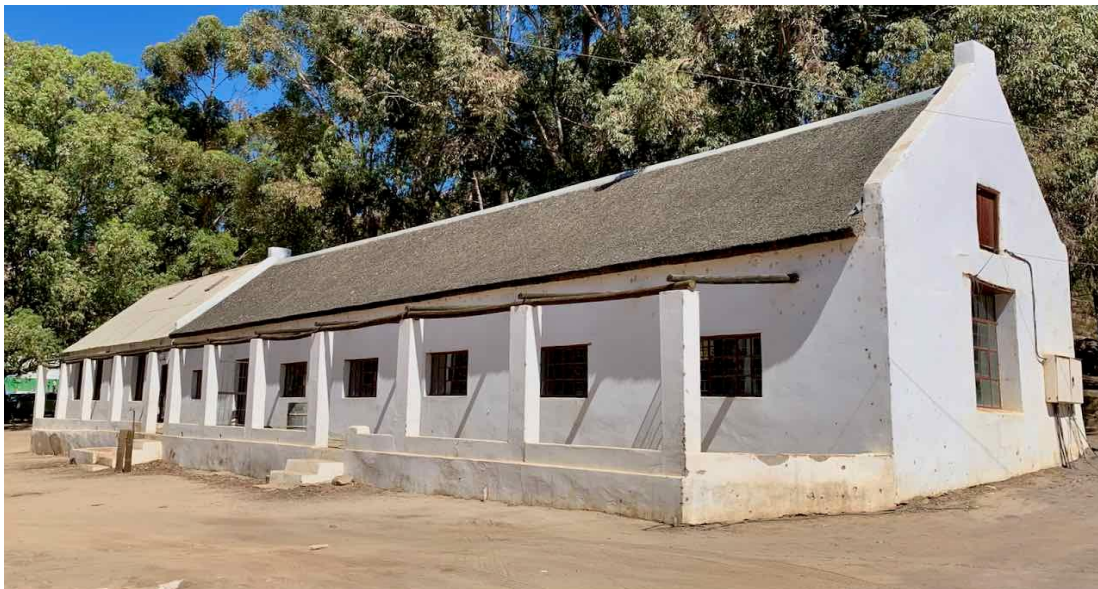
Figure 18E: Exterior of the Shoe Factory after refurbishment. The extension on the far left was provided with a thatched roof to match the roofscape of the rest of the town centre. The interior was refurbished to provide a shop for the factory. The steel windows were retained. (Image: ARCON, 8 June 2021).

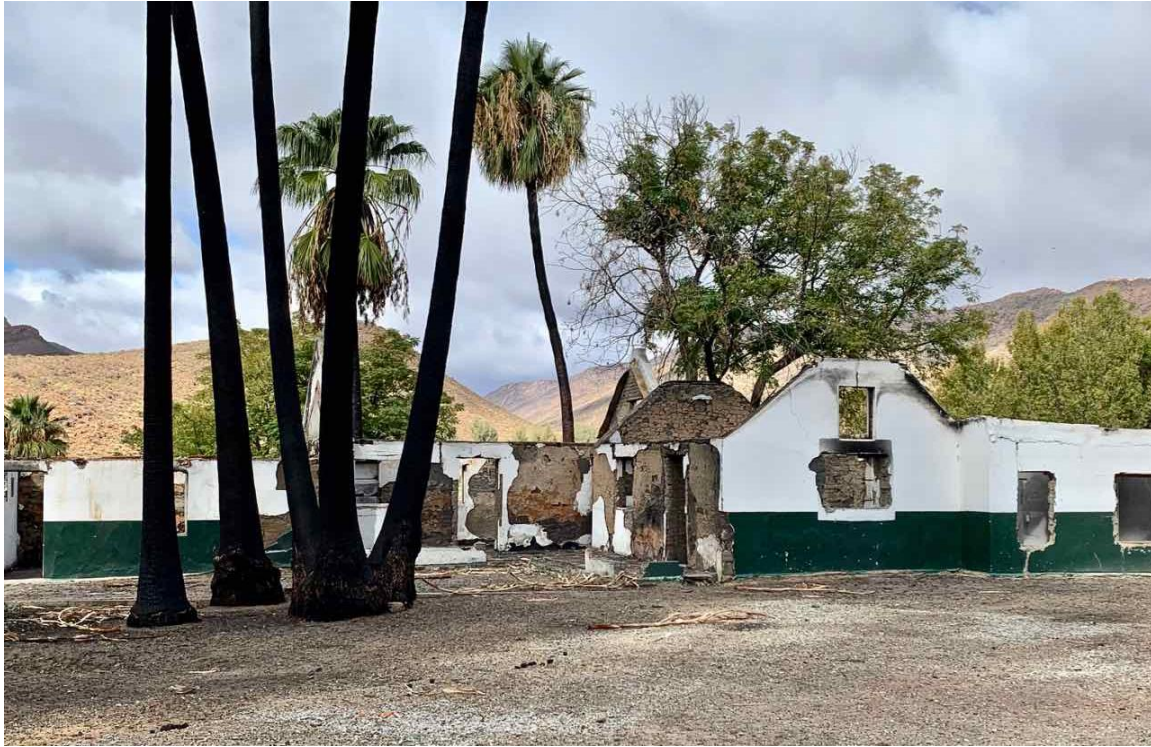
Figure 19A: The Old Tannery after the fire. Burning palm fronds played a large role in spreading the fire in the strong wind that had prevailed. (Image: ARCON, 26 May 2020)

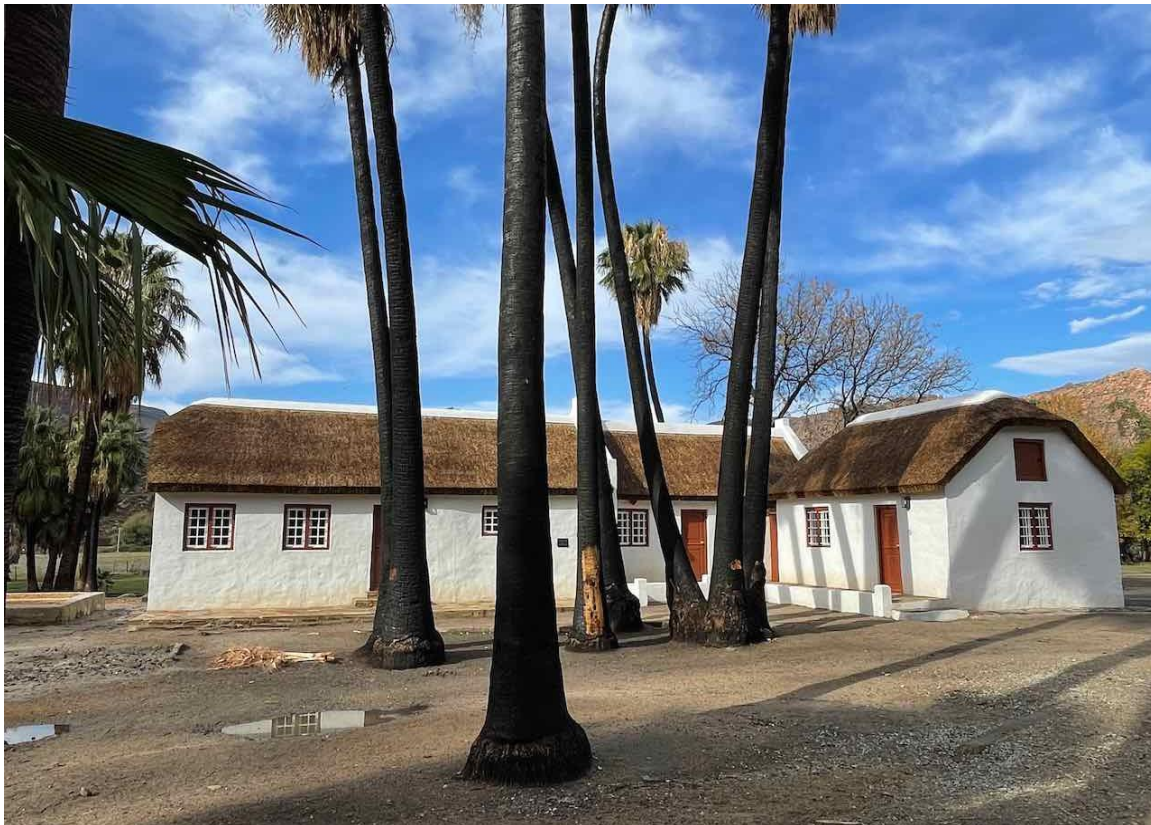
Figure19B: The Old Tannery after restoration/reconstruction. Part of one of the old tanning tanks is just visible in line with the building on the extreme left. (Image: ARCON 4 May 2021).

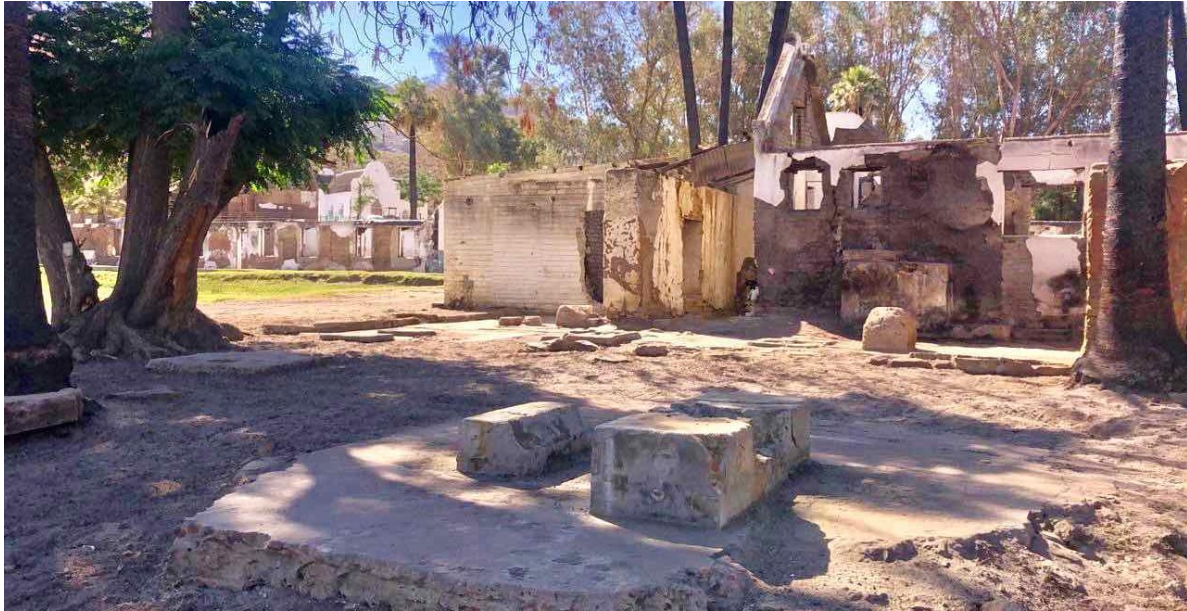
Figure 19C: View of the back (southwest end) of the fire gutted shell of the tannery. The fabric on the extreme left comprised the remains of a shallow mono-pitch extension which has stylistically latter 1950s/1960s bagged and horizontally raked 1 brick thick walls constructed with cement mortar. The burned-out shell of one of the school hostels is visible in the background to the extreme left. The cement and concrete slabs and bases in the foreground once formed part of the now defunct tanning operation. These elements were finally removed after the project archaeologist gave the go-ahead. The old concrete tanning tanks (not visible in this image) were retained. (Image: ARCON, 6 December 2019)

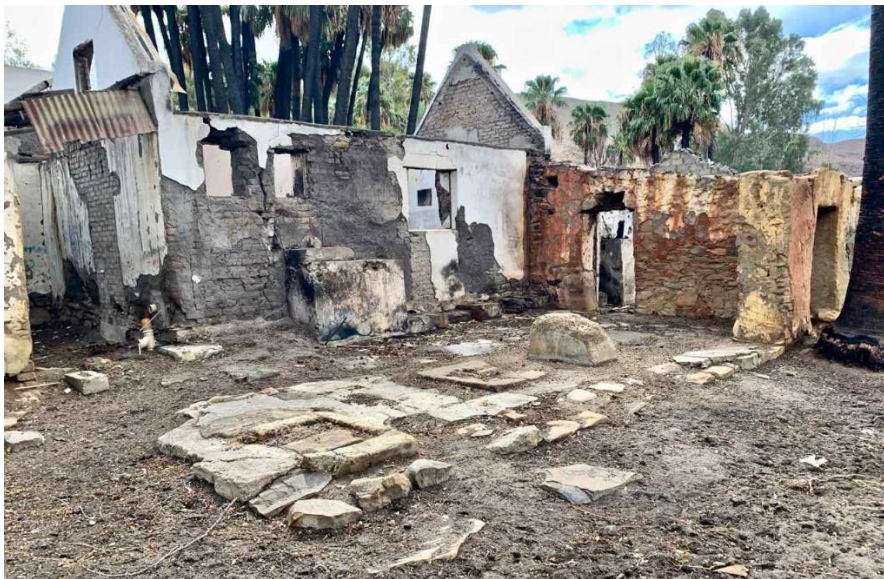
Figure 19D: View of the back of the tannery after the fire (southwest end) showing various remnants of cement and concrete bases which once supported tanning machinery. The 'stoep' in the foreground was once under a lean-to roof, and remains of an old stone wall base are visible running diagonally across the foreground (Image: ARCON, 6 December 2019)

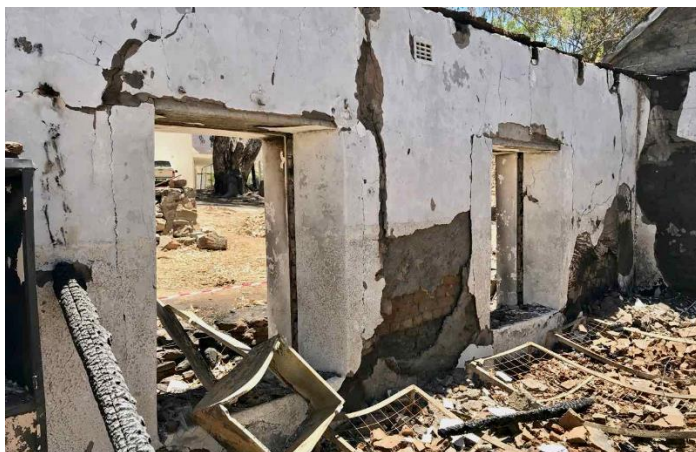
Figure 20C: Part of one of the hostel interiors shortly after the fire. The twisted remains of hostel beds lie amongst the wreckage. (Image: ARCON, 24 January 2019)

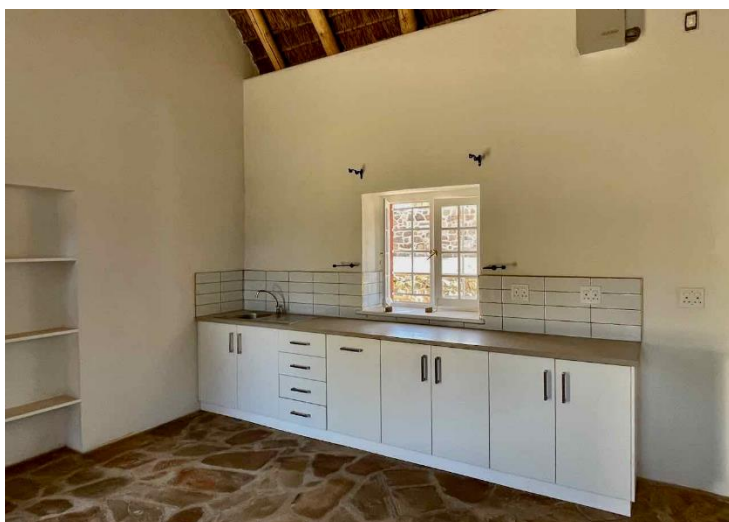
Figure 20E: Kitchenette in one of the guest flatlets. Door openings that were bricked in were left recessed as a record of that opening, and to double as shelf space. (Image: ARCON, 4 May 2021)

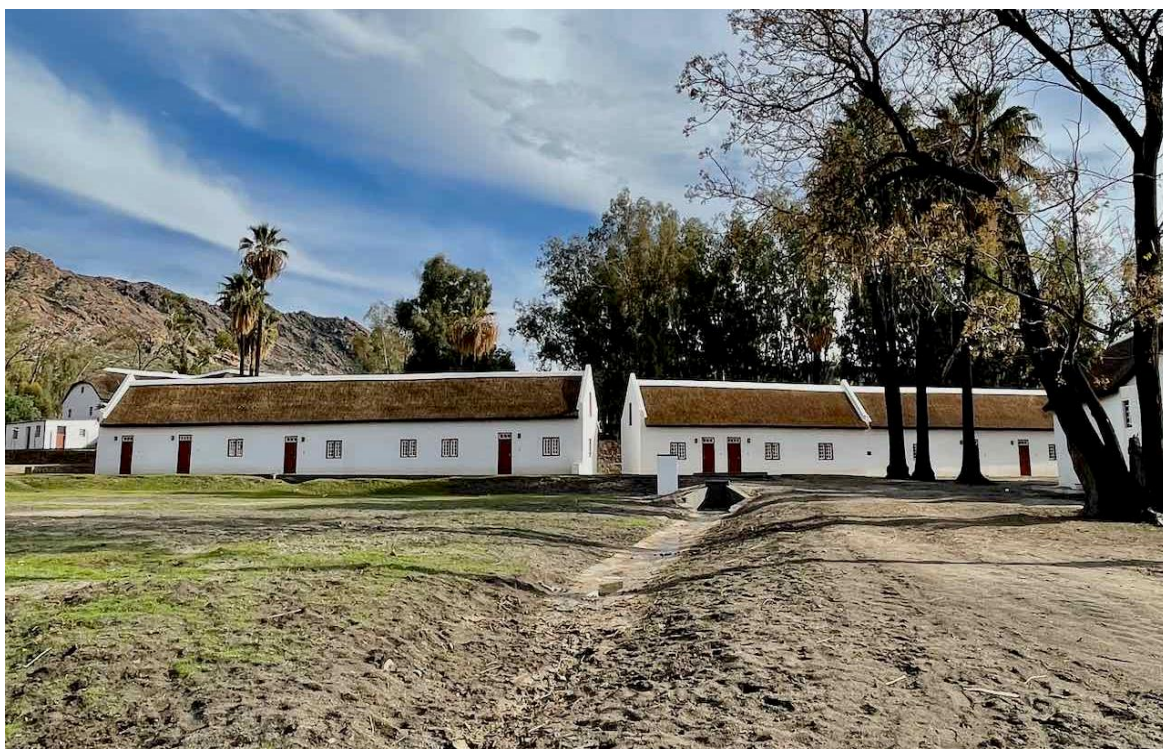
Figure 20F: View of both restored hostel buildings now repurposed as guest accommodation for the village. The channel and outfall in the centre of this image is part of a new stormwater system installed by the Foundation to control flood waters which had previously been a problem, after heavy rains. (Image: ARCON, 4 May 2021)

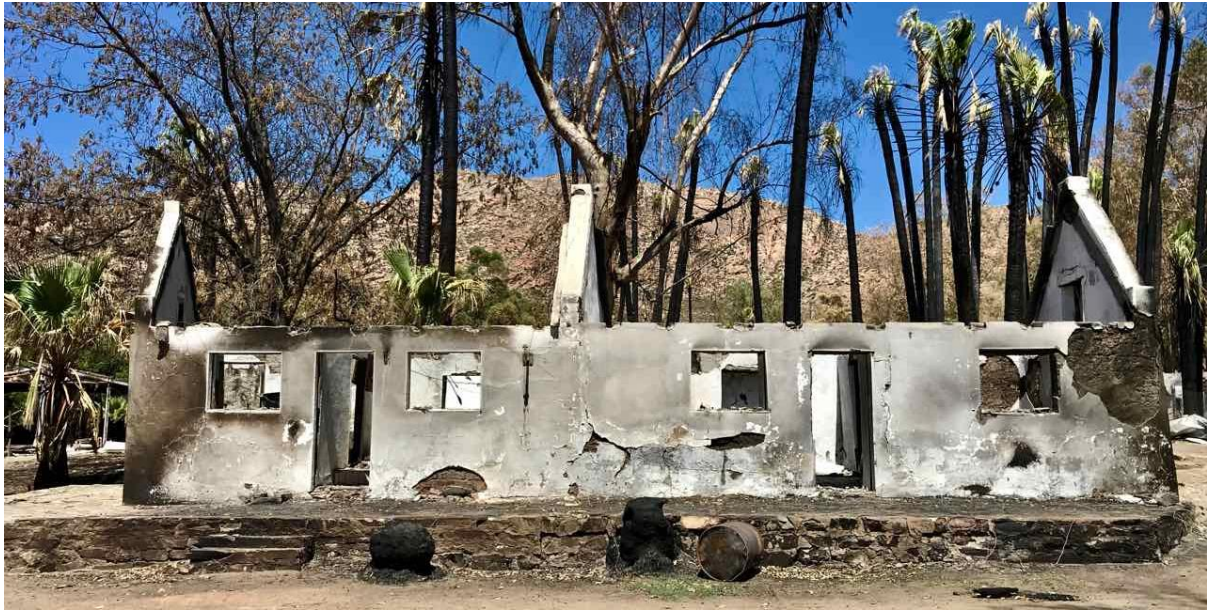
Figure 21A: The gutted Palms Guest House after the fire. (Image: ARCON, 24 January 2019)

The date of the Palms Guest House is not known. However, it is suspected that this small building was constructed in the late 19th/early 20th C, and therefore more recent than the other historic buildings in the town centre. It was one of only two guest houses in the village prior to the fire. Like many of the thatch buildings in this part of the village, it was flaming palm trees in a high wind that caused its demise. Consequently, palm trees closest to this and other buildings in the area were removed in the interest of future fire safety.

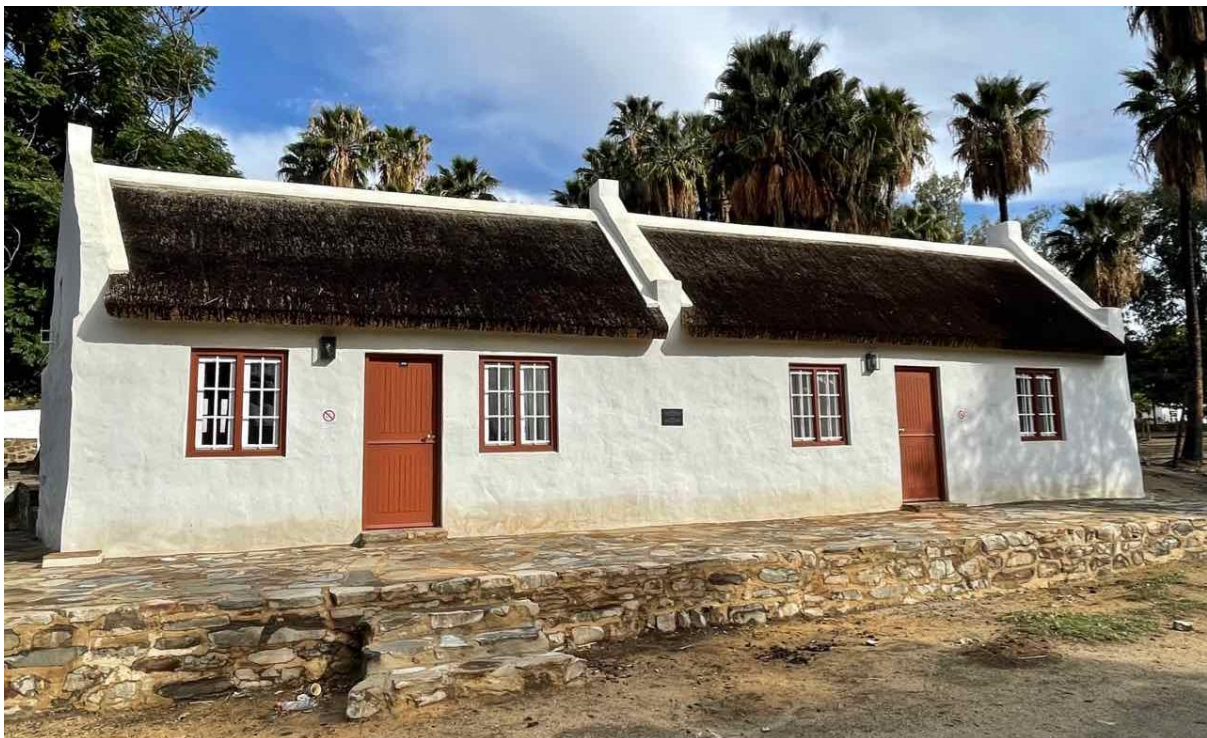
Figure 21B: The Palms Guest House after restoration. (Image: ARCON, 24 January 2019)

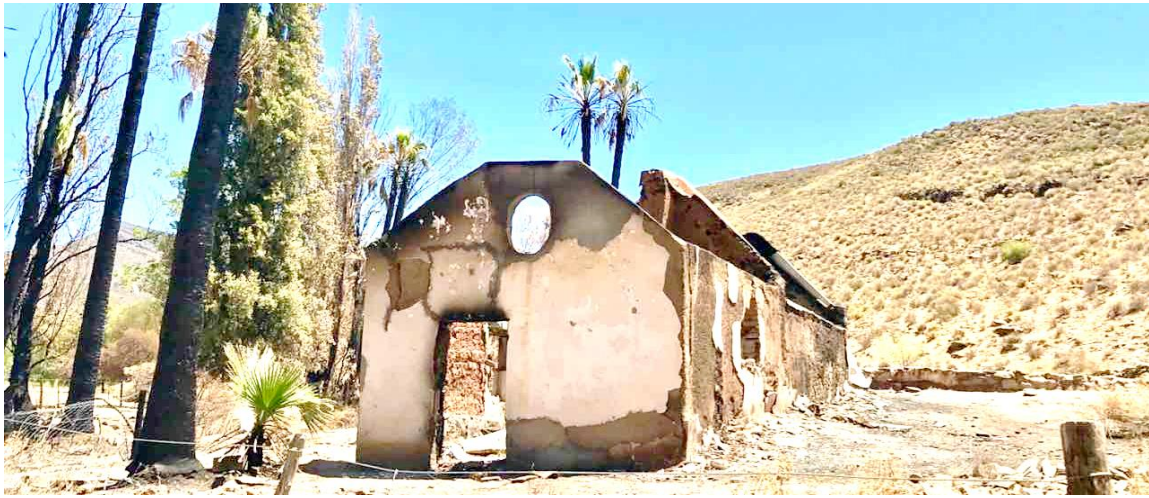
Figure 22A: The gutted Blacksmith's Shop after the fire. (Image: ARCON, 24 January 2019)

The Blacksmith's Shop was the first building to be gutted in the fire, having been closest to where it started. The age of the building is not known but judging from its plastered masonry construction, which is similar to that of Leipoldt House, it could be that the part closest to the adjoining threshing floor is another of the original Riedmond farm structures. The Blacksmith's Shop is on two levels and, with the threshing floor adjacent to a stream has on occasions, created the mistaken impression that this was once a mill. The lower level contains the remains of a forge which would have been strategically placed for attending to wagon wheels damaged during the torturous mountain descent to the settlement.

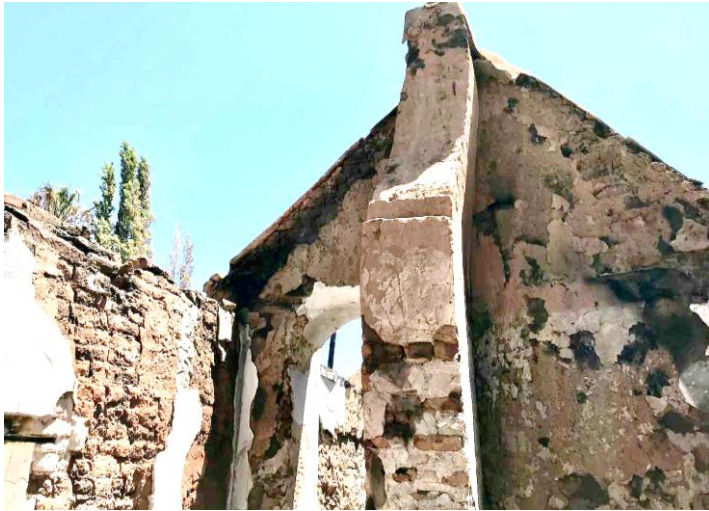
Figure 22C: The remains of the forge flue after the fire. (Image: ARCON, 24 January 2019)

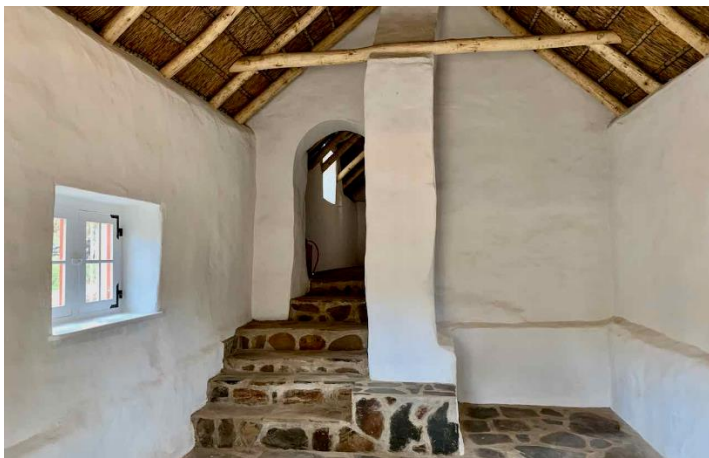
Figure 22D: The forge area after restoration. The forge was not reconstructed as the building is earmarked to be the new information centre for the town. The extra floor area was needed for office space. (Image: ARCON, 9 July 2020)

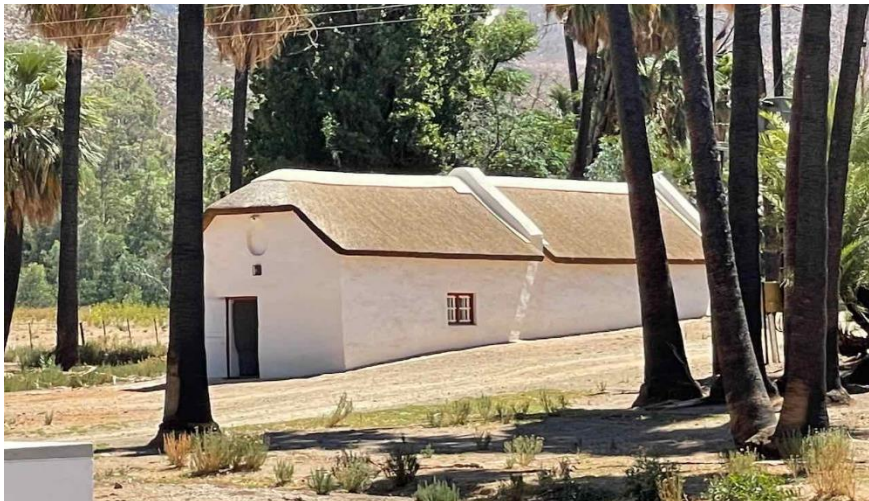
Figure 22E: The Blacksmith's Shop after restoration. (Image: ARCON, 23 February 2021)

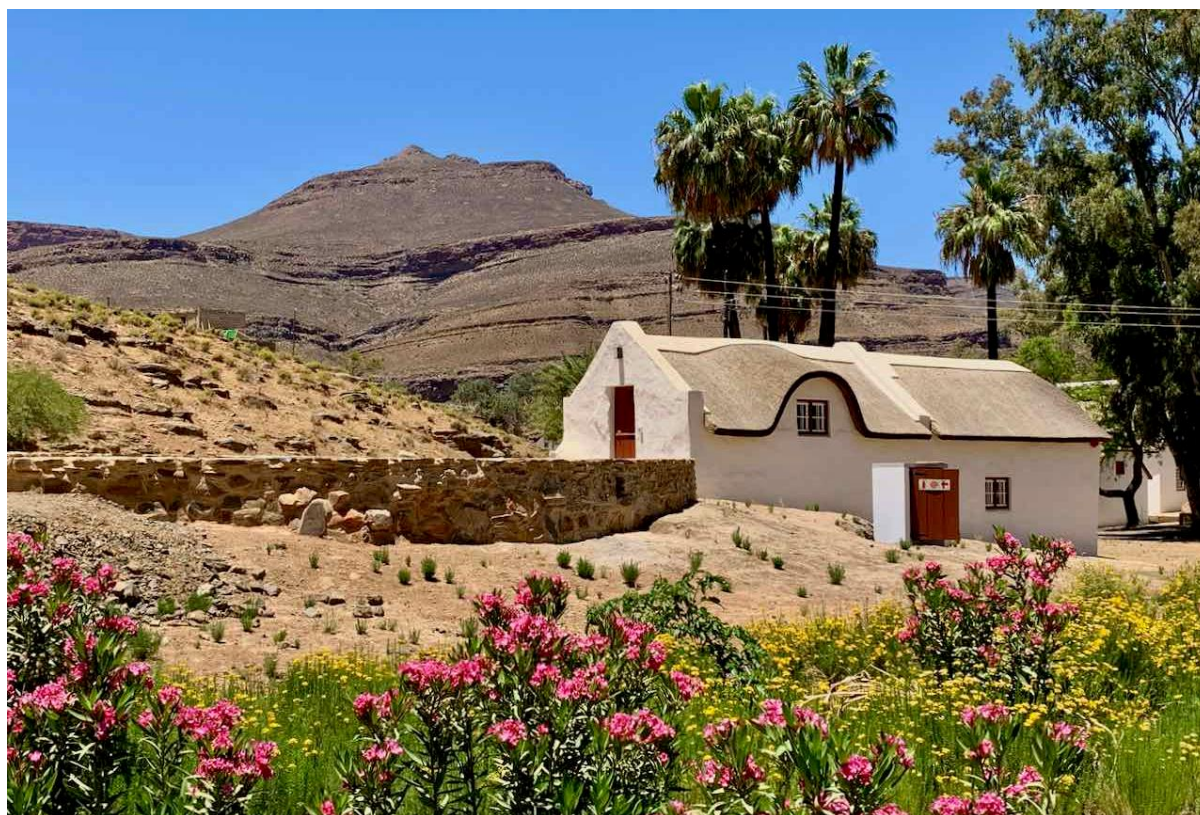
Figure 22F: The Blacksmith's Shop with threshing floor on the left and a fire hydrant kiosk to its right. It was not initially intended to restore the threshing floor, but it was in such bad condition that the Foundation agreed to include it in the program. The roof dormer is a new insert to provide natural light to an otherwise dark upper level after it was decided to use the building as the town's information centre. (Image: ARCON, 23 February 2021)

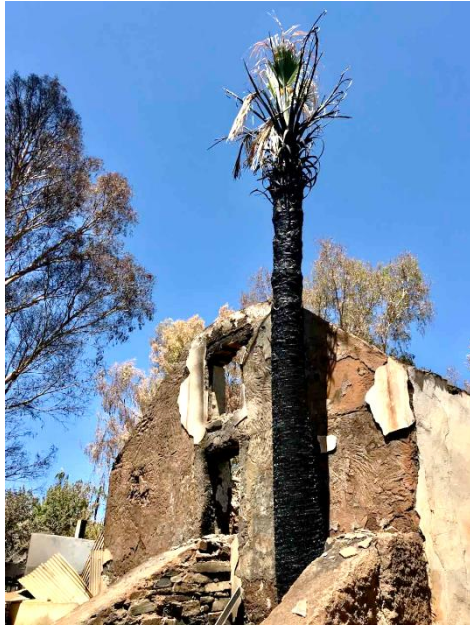
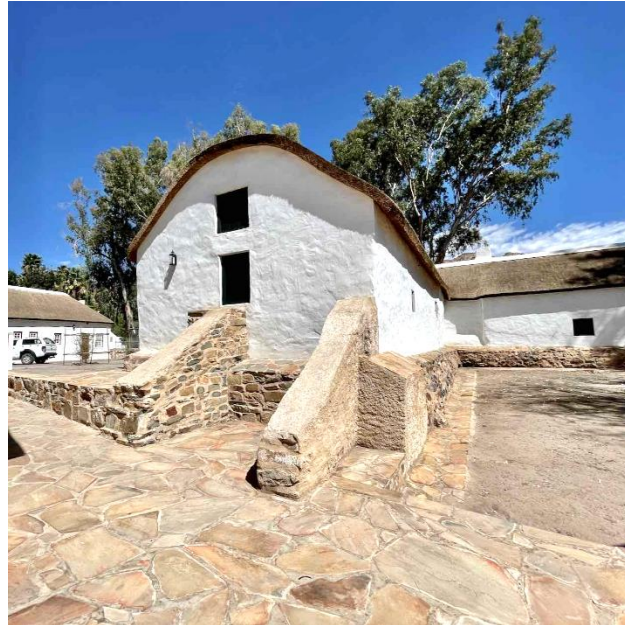
Figure 23C: Left: A palm next to the Winkelhuis was another example of a tree removed for fire security reasons. This image also indicates the emergency propping installed shortly after the fire using locally available timber to prevent a gable collapse. Right: the size of the root bowl of the palm after its removal. (Images: ARCON, 24 February 2019 and 11 October 2019)

Trees, and especially palm trees, had played a significant role in spreading the fire in the strong wind that had prevailed on the day. As a future fire precaution, a number of these trees were removed with the approval of Heritage Western Cape (Wupperthal is a designated Heritage Area) while retaining the majority due to their strong role in defining the character of the Church Precinct.

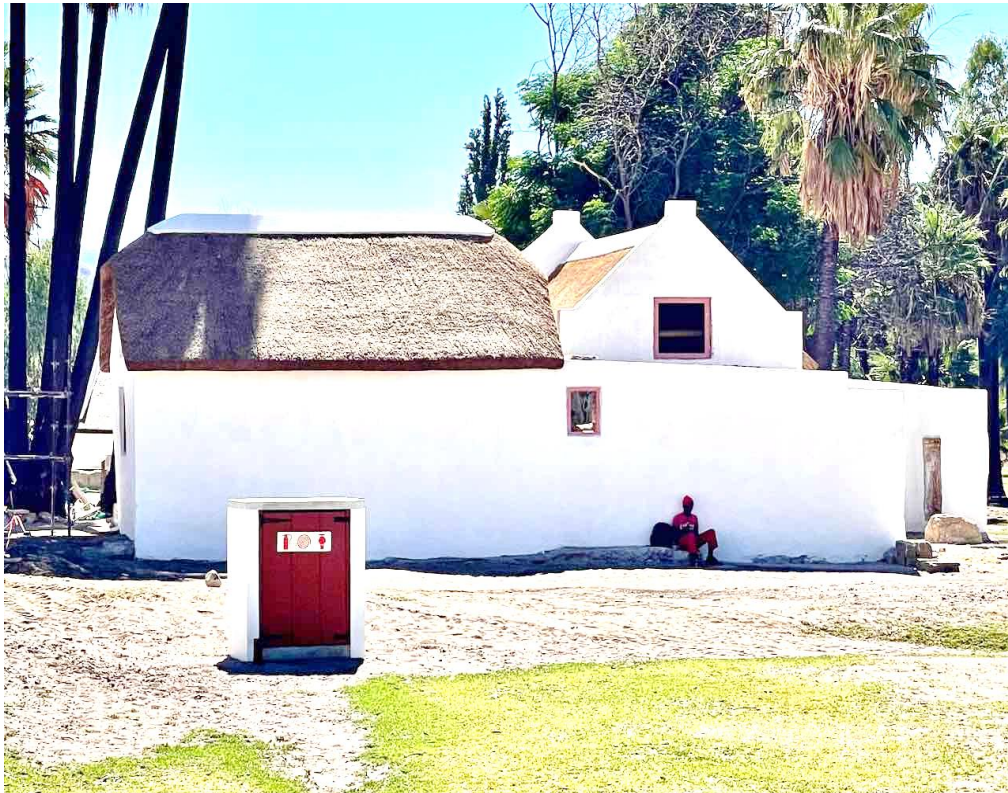
Figure 23E: New fire sensor and alarm systems were installed in all the restored buildings. Prior to the fire, the only alarm system in the settlement had been the church bell. (Images: ARCON, 7 April 2021)

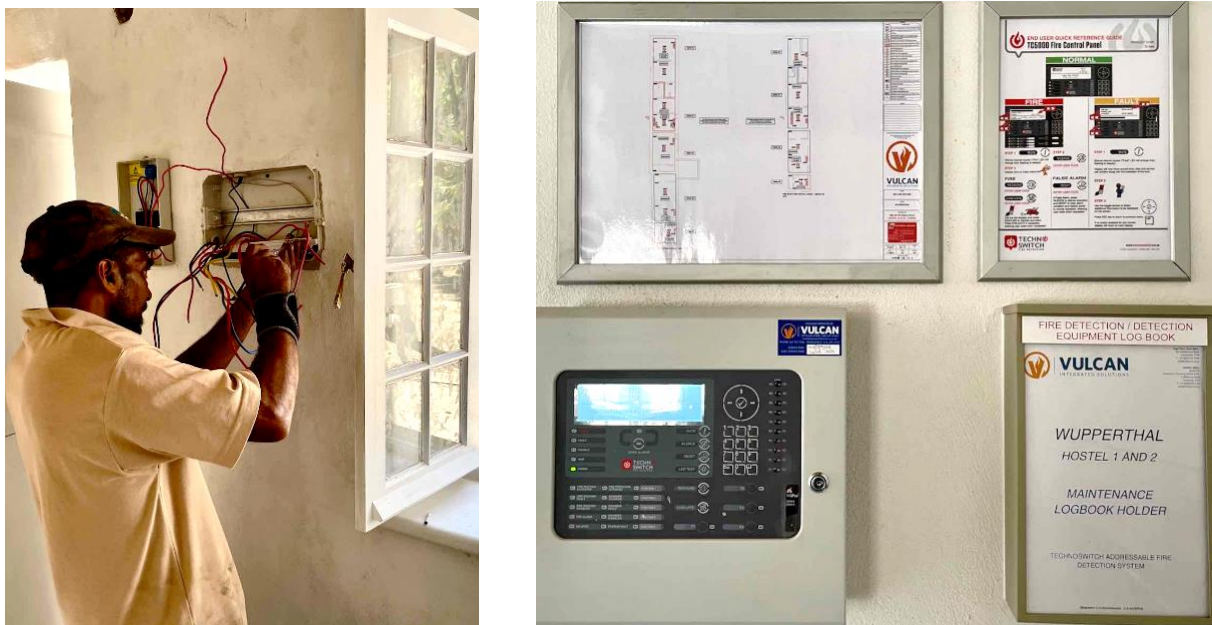
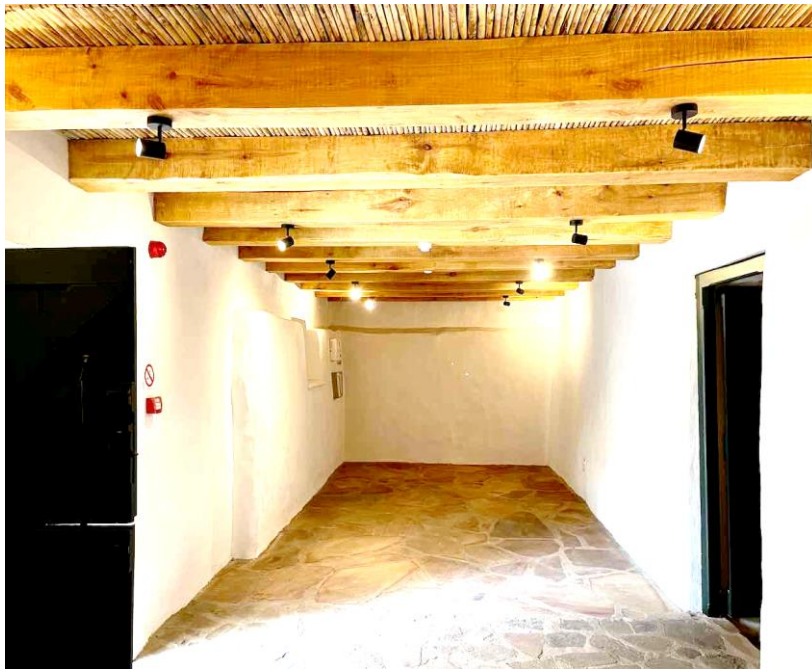
Figure 23F: New fire alarm system in Leipoldt House. The panic button and red alarm light are next to the front door (left) with the control panels at the left far end. Smoke detectors are mounted to the underside of new rafters supporting a new brandsolder and reed ceiling. (Images: ARCON, 8 June 2021)

Brandsolders (fire retardant ceilings to catch burning thatch) employing contemporary lightweight but highly effective fire-resistant screeds were re-installed in the buildings where ceilings had previously existed, i.e. Leipoldt House, the Mission Stores, Winkelhuis and Parsonage. Contemporary fire detection systems with alarms were installed in all restored buildings together with statutorily required fire

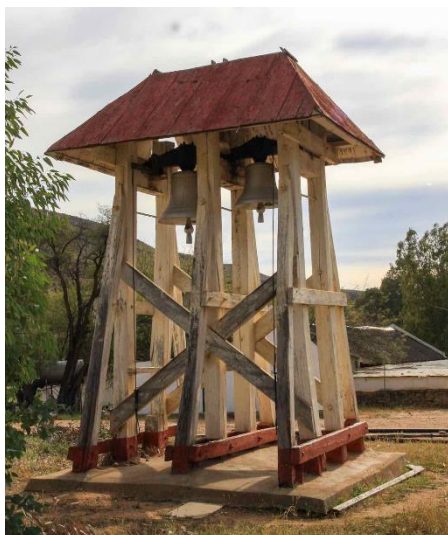
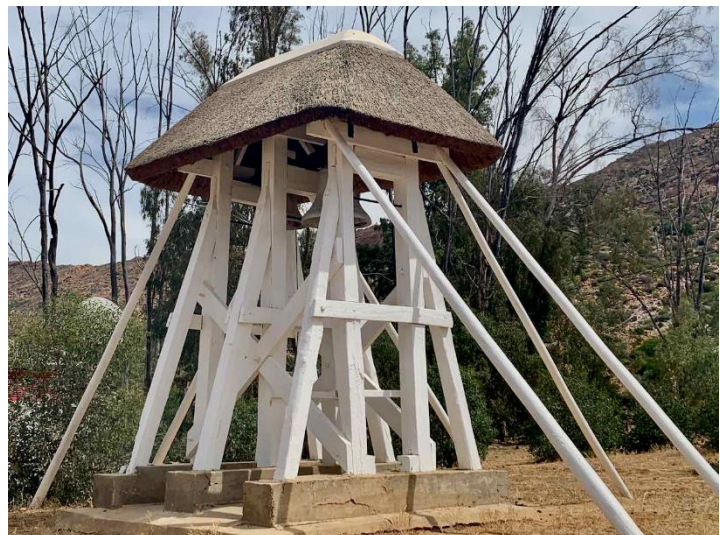
Figure 24A: The campanile behind the church. Left: before refurbishment. Right: the campanile after refurbishment. The stays had been added by the locals at some stage after the 2009 photograph on the left and did not form part of the restoration project. (Image left: Gabriel Fagan Architects, 22 September 2009; right: ARCON, 27 October 2020)

Due to the poor condition of the timber framed campanile and adjacent church ablution block it was decided to repair and refurbish these structures to bring them in line with the fire damaged buildings that were being restored.

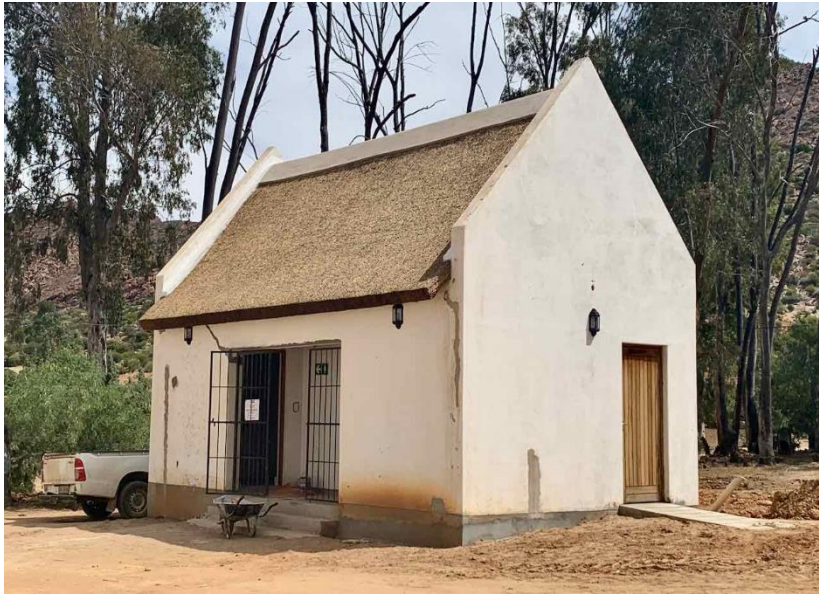
Figure 24B: The church ablution after re-thatching and undergoing crack repairs prior to repainting. (Image ARCON, 27 October 2020)

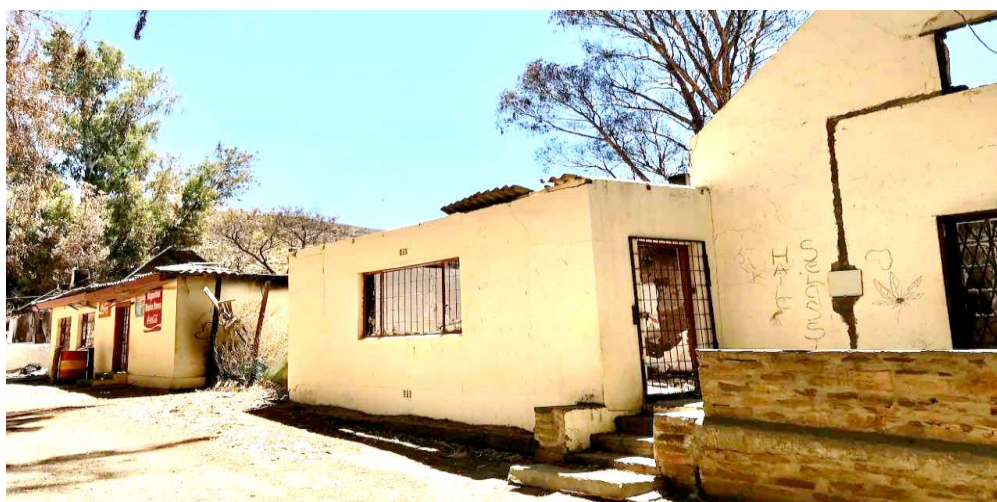
Figure 26A: The western end of the Mission Stores with flat roofed kitchen extension (centre) and the derelict café building on the far left. (Image ARCON, 24 February 2019)

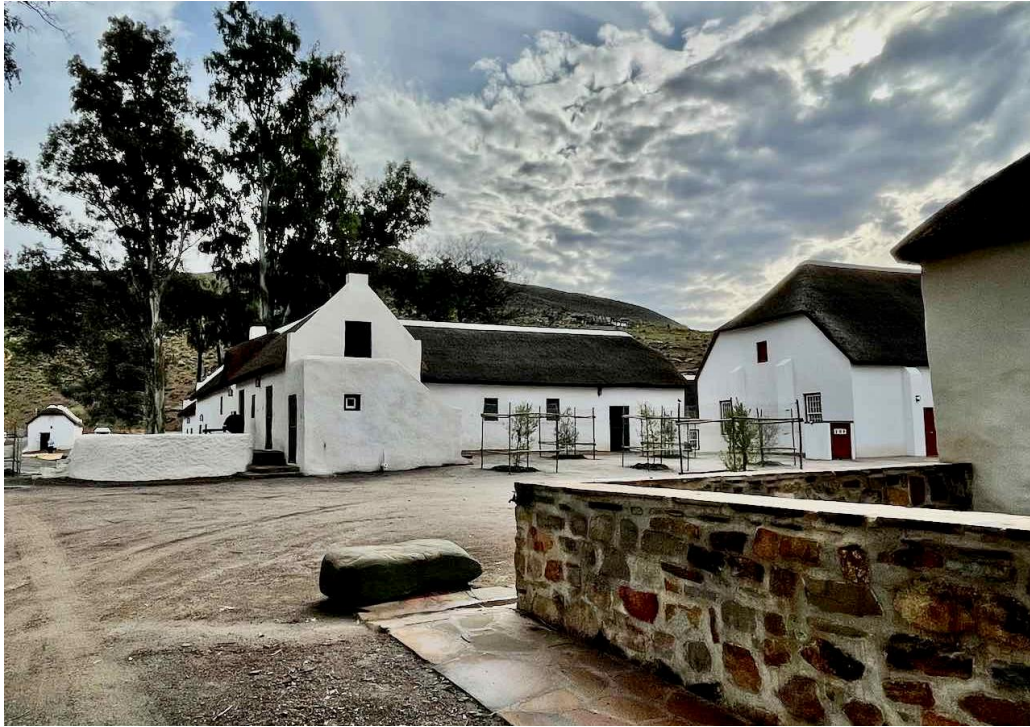
Figure 26B: The same view but with the kitchen extension and derelict café now removed, reclaiming the open space between the mission Stores and Leipoldt House. (Image ARCON, 8 June 2021)

It therefore wasn't long after the decision to add the hostels to the restoration programme that it was realized that a logical extension of that work would be to repair the seriously deteriorated retaining walls behind these buildings. That was followed by a decision to repair the stone walls along the approach to the church and landscape the re-opened space between the Mission Stores and Leipoldt House. This space was created after demolishing a derelict, poorly built latter 20th C café building constructed out of cement blocks alongside Leipoldt House. After much discussion, it was decided, with the support of the

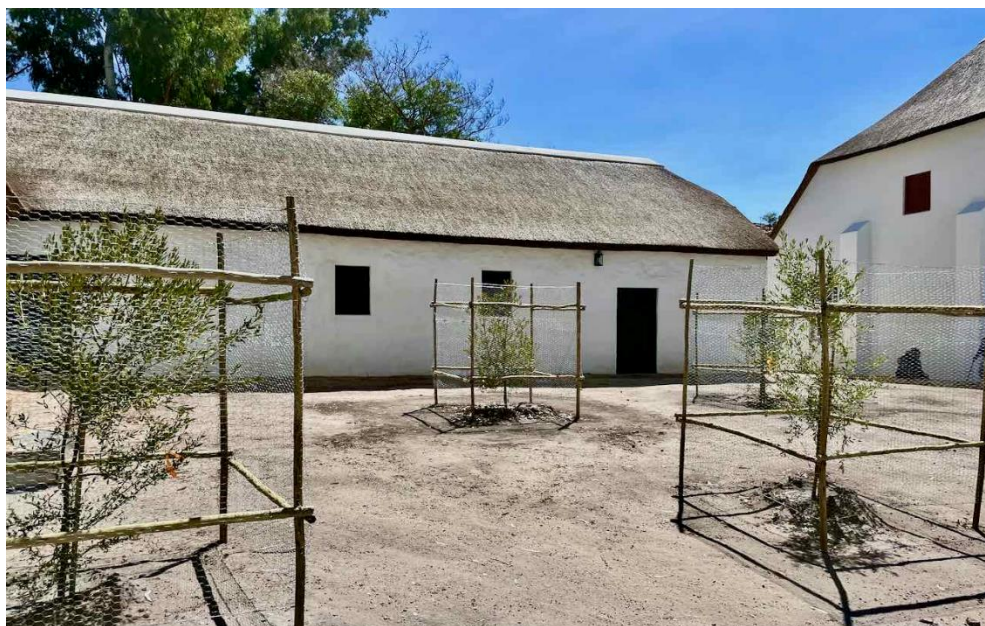
Figure 26C: Simple new landscaping in the reclaimed open space after the demolition of a derelict café building between Leipoldt House and the Mission Stores. The tree enclosures comprise hand cut local laths and diamond mesh fencing to keep wandering donkeys at bay. The rear wing of Leipoldt House is in the background. (Image ARCON, 27 October 2020)

Moravian Church, to plant olive trees in a part of the reclaimed open space and in the large, uncultivated area to the east of the Old Parsonage. The purpose was to keep the design very simple and in keeping with the biblically rustic quality of the area.

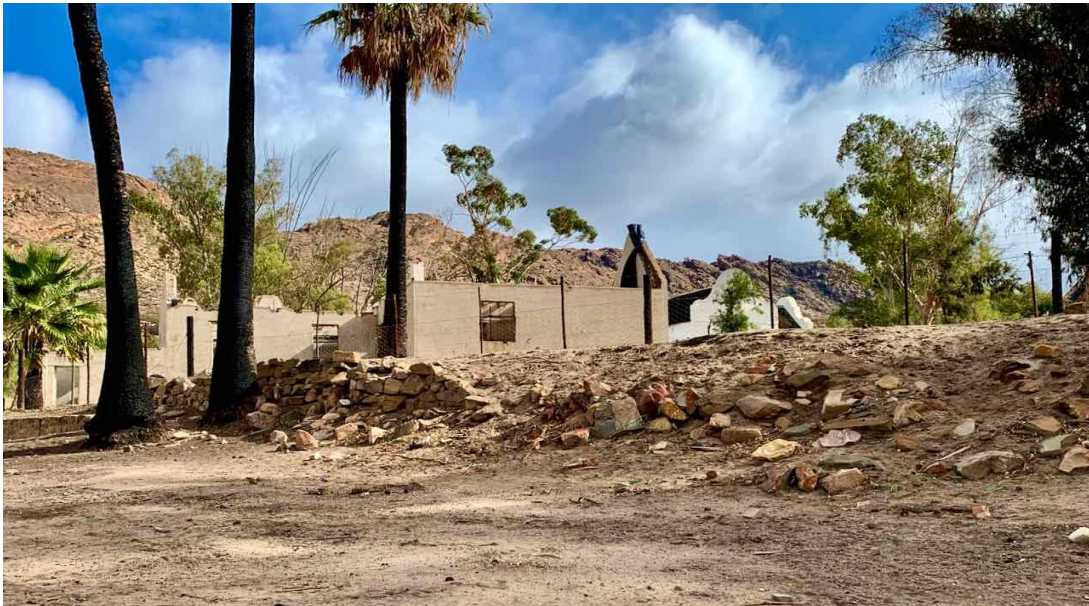
Figure 26D: The semi-ruined stone retaining wall behind the Hostel Buildings. The Old Parsonage is left of centre with the Church to the right of centre beyond. (Image ARCON, 26 May 2020)

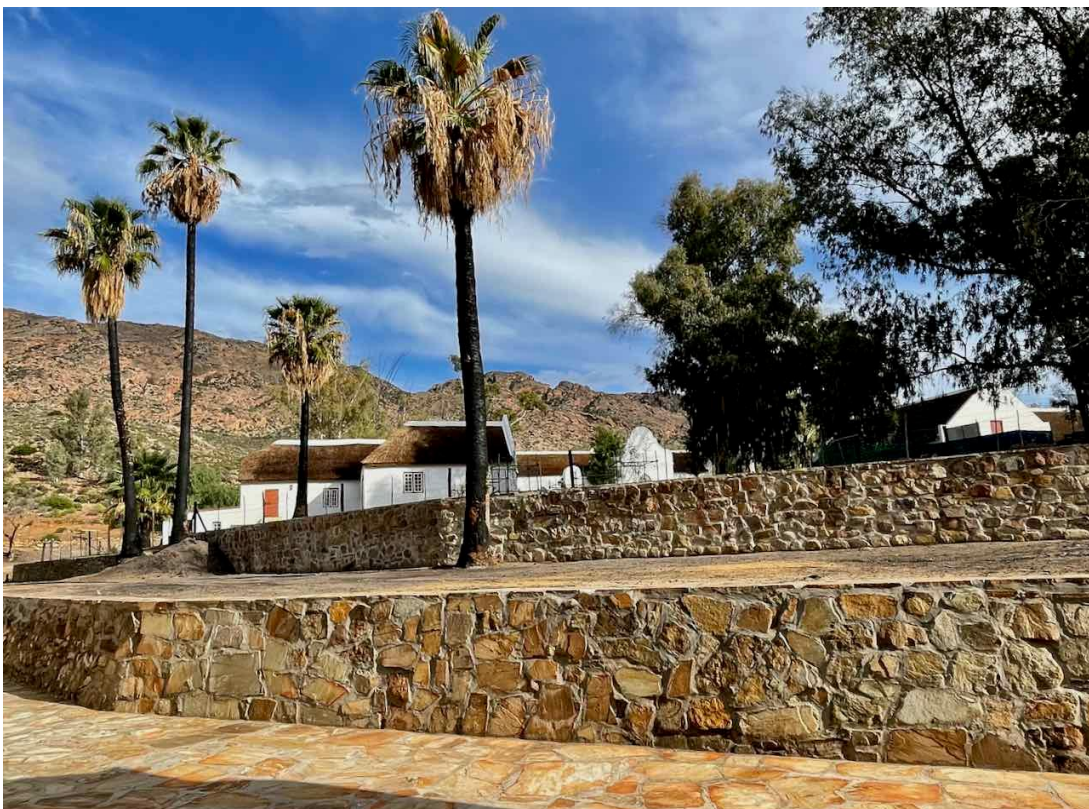
Figure 26E: The stone retaining walls after reconstruction behind the Hostel Buildings. (Image ARCON, 8 June 2021)

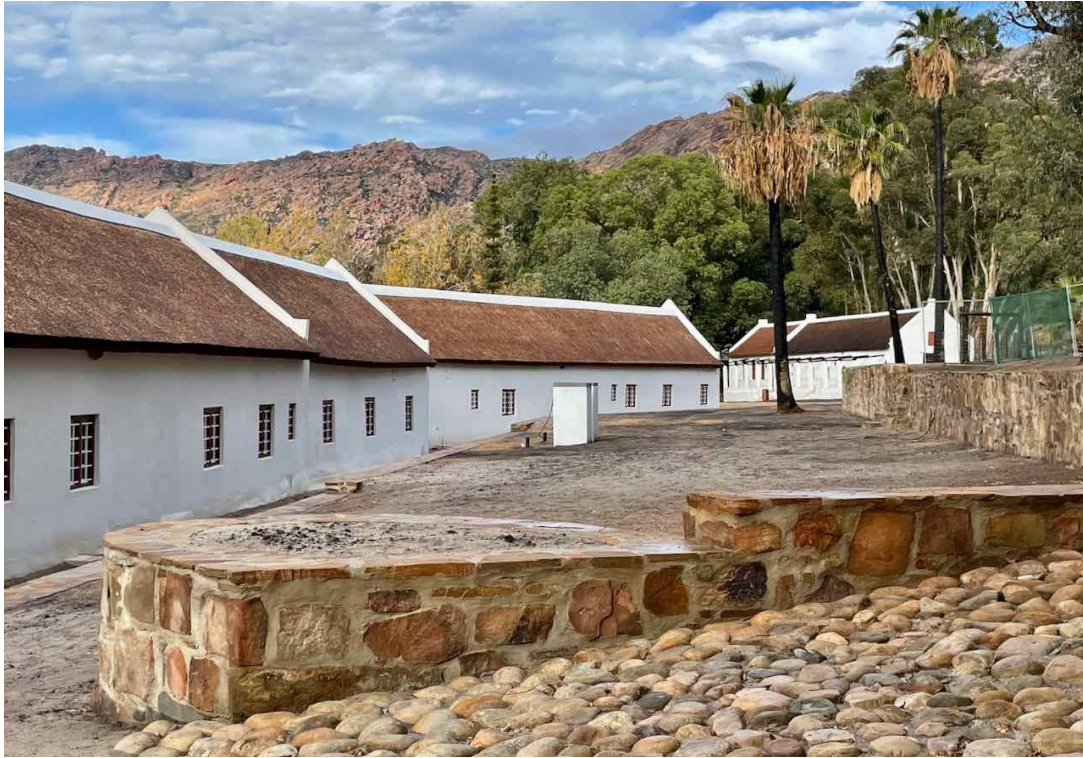
Figure 26F: Reconstructed stone walls behind the restored Hostel Buildings (left). The Shoe Factory is in the background to the right. (Image ARCON, 8 June 2021)

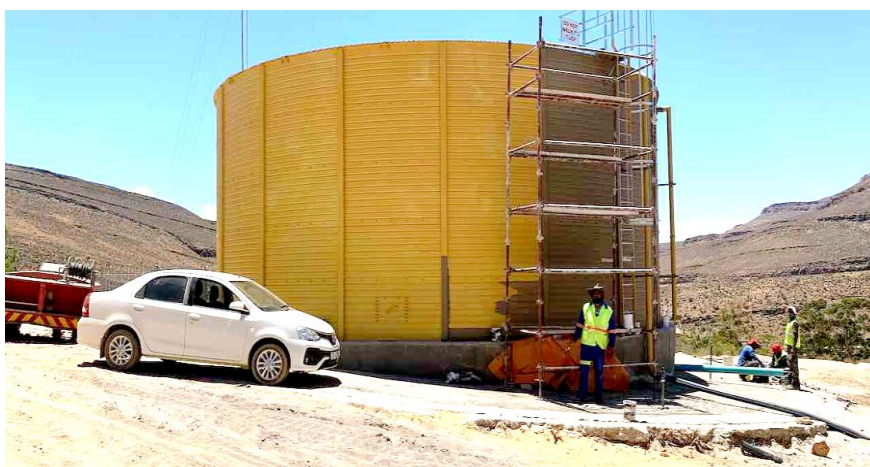
Figure 27A: The new reservoir funded by the Foundation nearing completion. (Image ARCON, 14 January 2021)

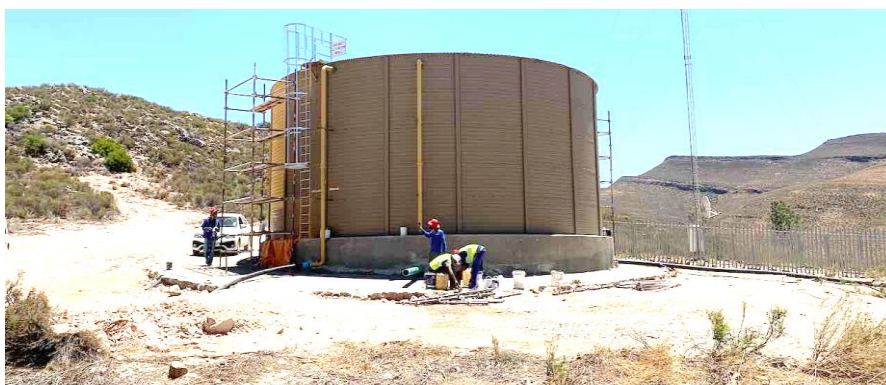
Figure 27B: The new reservoir painted to match the surrounding mountainsides but is in any case largely obscured from the Church Precinct below. (Image ARCON, 14 January 2021)
