VASSA Journal

The rescue restoration of the historic town centre of Wupperthal Mission Station Cederberg,

South Africa, 2019-2021 | Graham Jacobs

Rebuilding homes after the fire of 2018 | John Wilson-Harris

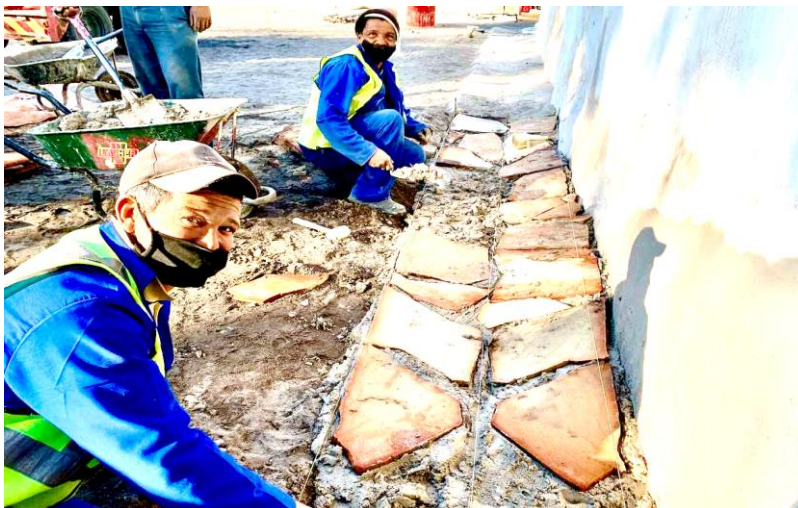
6 August 2020: Laying new rainwater channels for Leipoldt House.

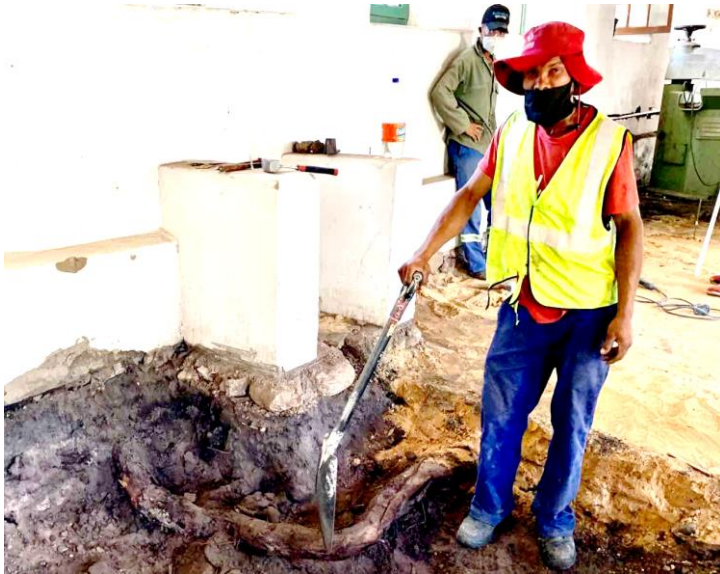
27 November 2020: Removing a massive tree root under the Shoe Factory floor.

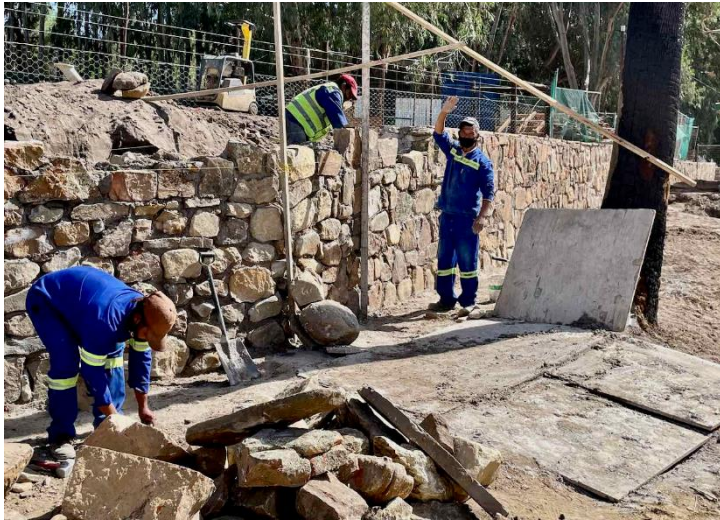
9 March 2021: Reconstructing the retaining walls behind the School Hostels.

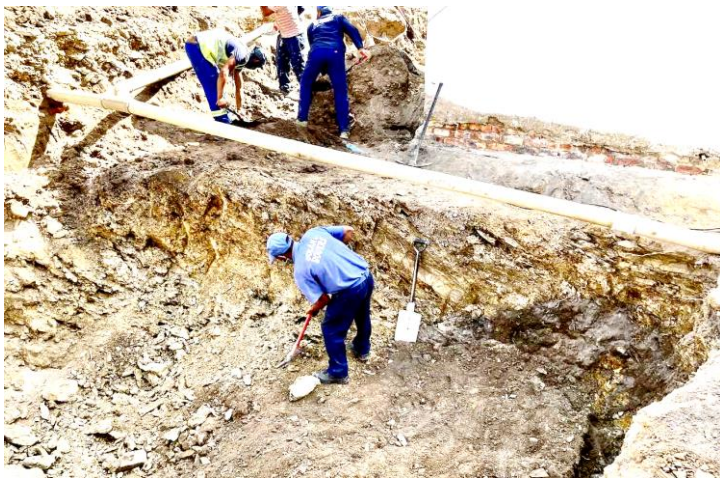
9 March 2021: Digging the massive new underground sump behind the School Hostels as part of a system to alleviate future stormwater flooding.

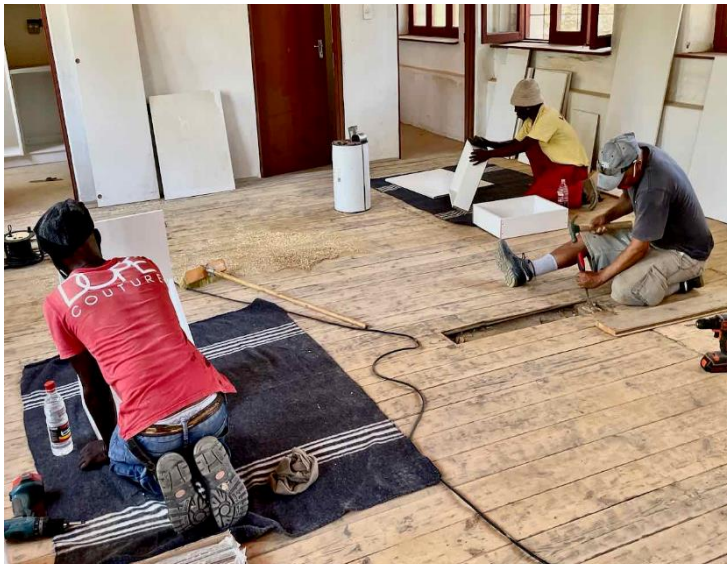
23 March 2021: Repairing the floor in the new Shoe Factory shop space.

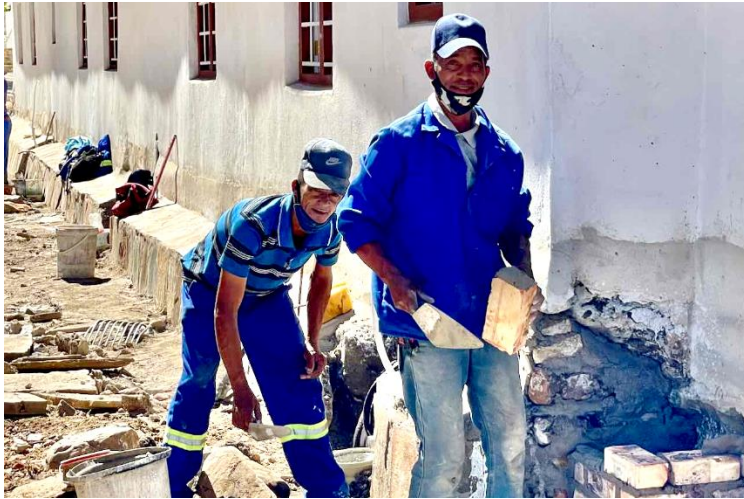
7 April 2021: Wall repairs at the back of one of the School Hostel buildings. The mortar has the appearance of Portland cement but is actually builder's lime mixed with a very dark local river sand.

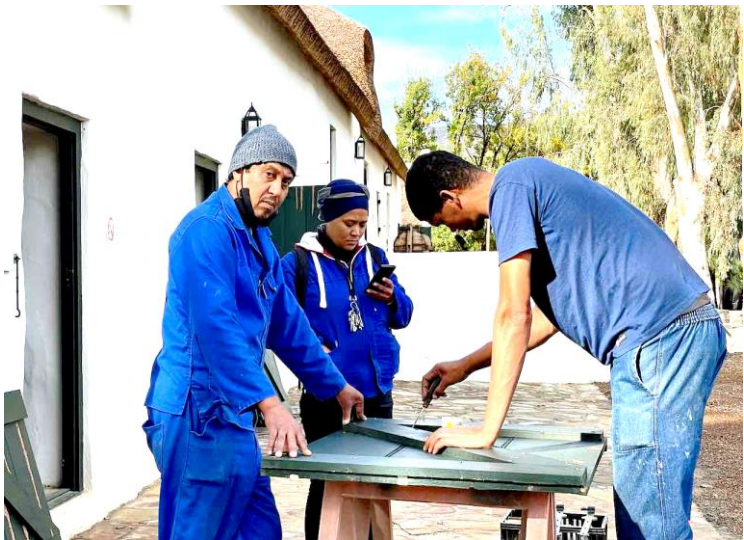
8 June 2021: Hanging new doors at Leipoldt House.

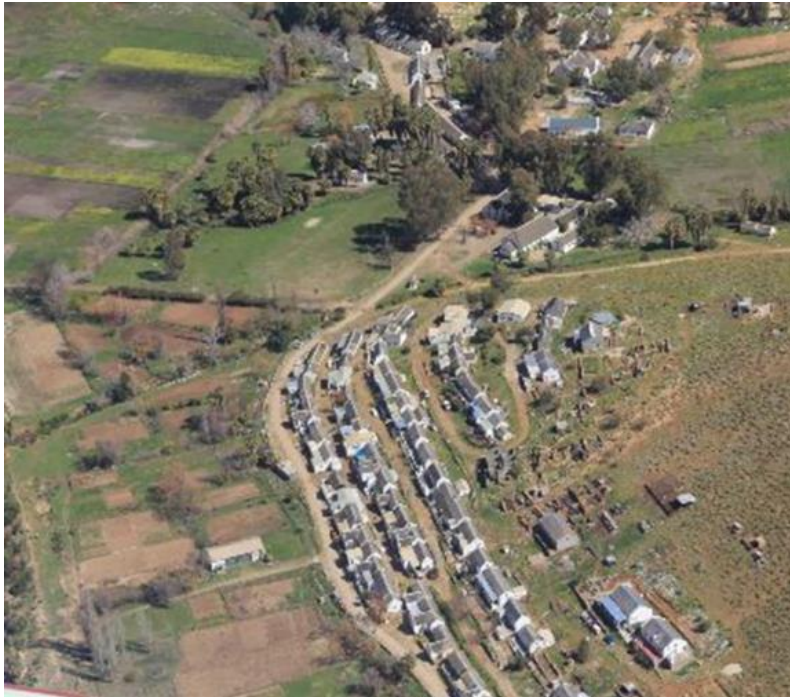
Figure 4: Before.

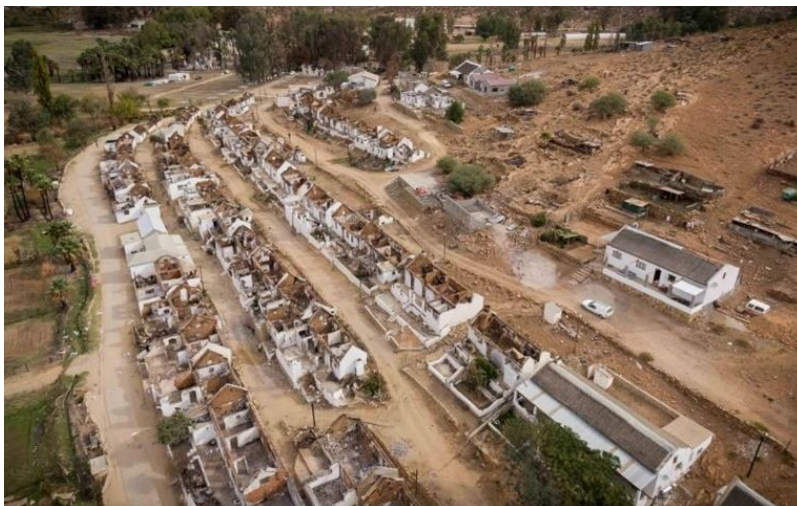
Figure 5: After.

The fire of 2018 claimed one life and left some 200 people homeless. Public donations of money, clothing and consumables were made. Each household was eventually apportioned R72,000 from donations for rebuilding. The Department of Human Settlements constructed temporary housing on the village rugby field. Heritage Western Cape visited the village to assess the damage.

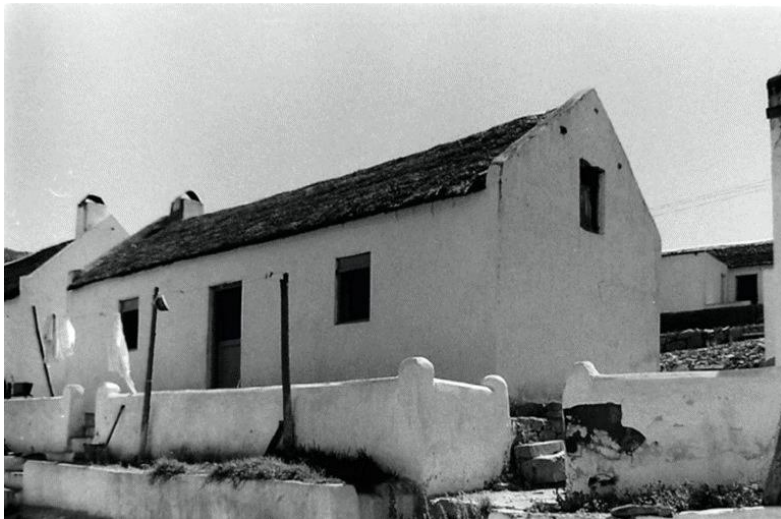
Figure 6: Photo of the front of 9 Middel Street.

Documentation was therefore required, and a call went out to the ClfA membership for any information and plans that might be available for use as a base for developing the necessary paperwork. Despite all the academic analyses through the years there was surprisingly little material. Focus of studies had primarily been on the werf buildings. There were no plans of the houses. The most valuable find was a set of photographs taken in 1979 from front and back of all the houses by Revel Fox Architects (examples Figures 6 and 7). These formed a baseline for all the later heritage assessments and were eventually included on all assessment sheets.

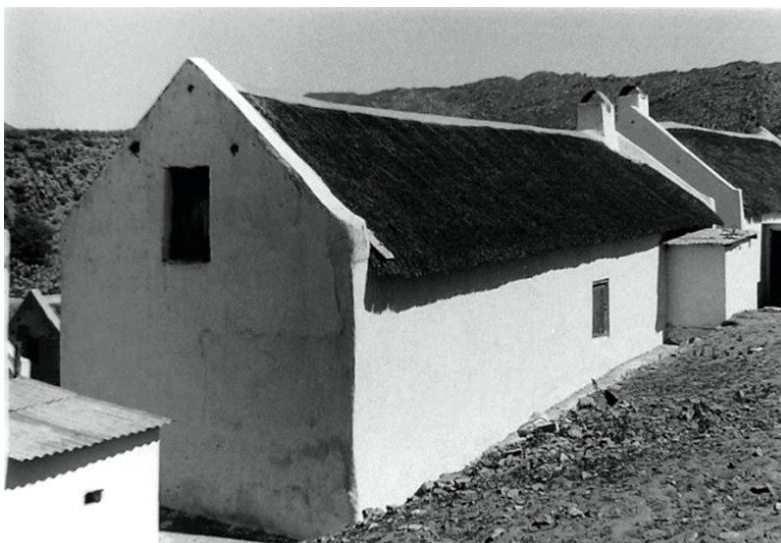
Figure 7: Photo of the back of 9 Middel Street.

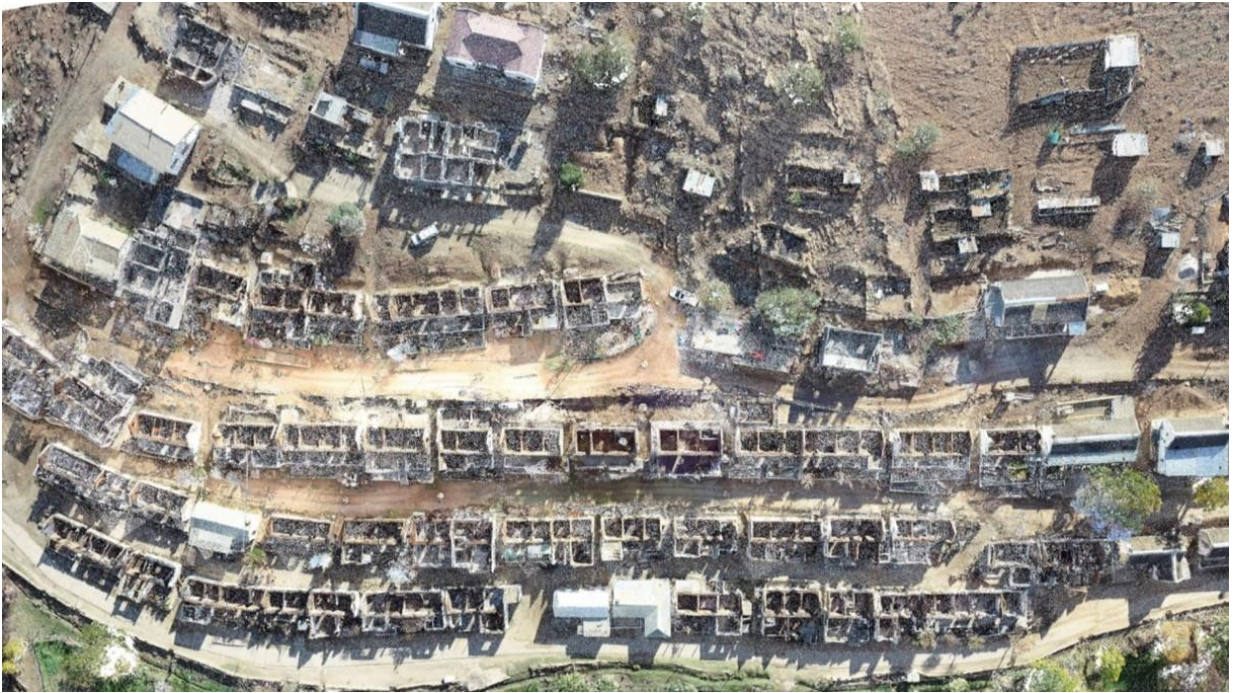
Figure 8: Point cloud survey - drone (Cape Survey, 2019)

After approaching various surveying practices to invite them to help with developing the basic layout drawings, Cape Survey offered pro bono assistance. They offered to undertake a point cloud scan of the buildings using a drone, augmented by scanning at ground level. After numerous delays in getting the drone down to Cape Town, it eventually arrived in Wupperthal on a stormy weekend in May 2019. Because of the inclement weather, the operators were only able to survey part of the settlement, and although architectural practices had offered the use of their software and expertise to translate the scans into usable documentation, the results were vague and of low definition (Figures 8 and 9). It was concluded that ClfA would have to find volunteers to measure up the buildings on site.

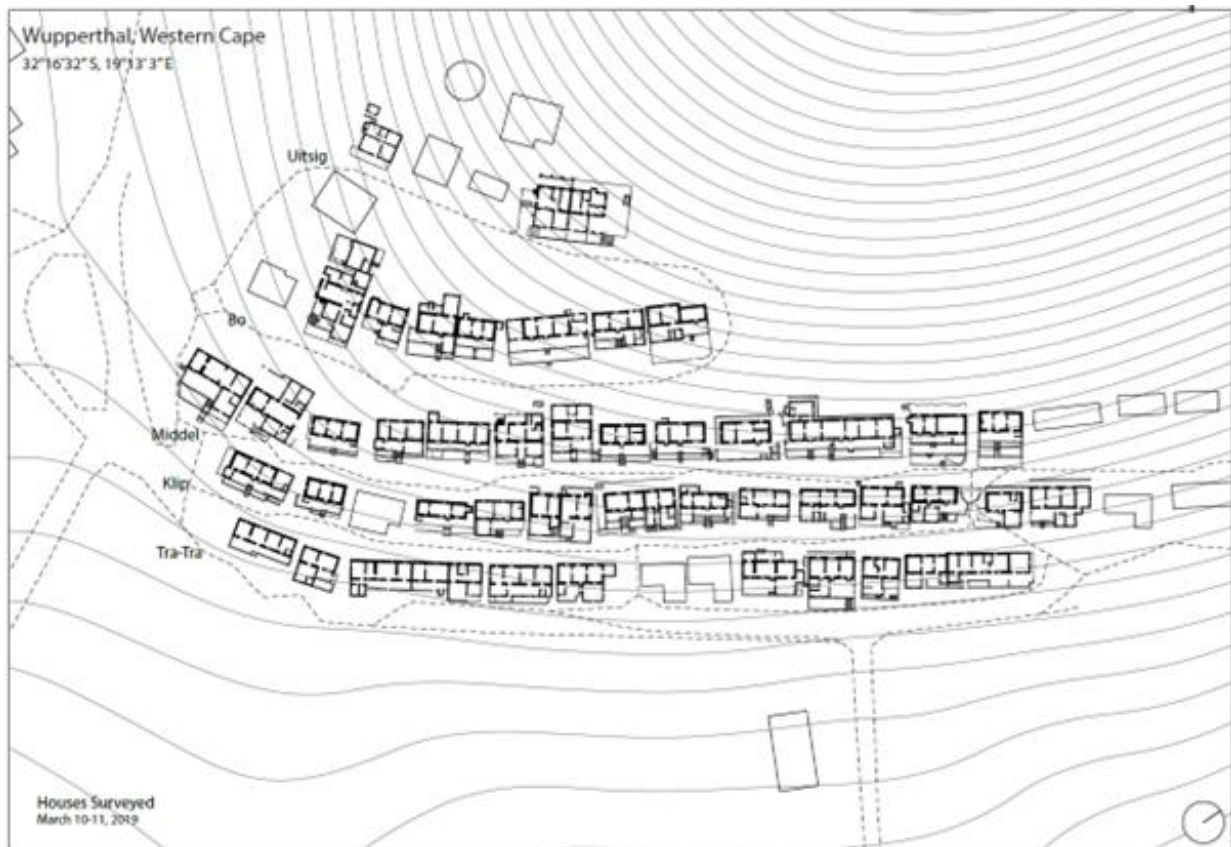
Figure 13: Students' compiled town plan (Van Jaarsveld et al., 2019)

On completion of their work in May 2019, Van Jaarsveld offered it to ClfA as a basis for their documentation, and it was gratefully accepted. Although SEA had envisaged seeing the project through to Heritage Western Cape submission, they were advised by HWC that the heritage authority might not accept their credentials to assign or establish the significance of the buildings or to motivate the proposed rebuilding work and specifications. The documentation included photographs (example Figure 10), site survey drawings (example Figure 11), and computer-aided design (CAD) drawings (example Figure 12), as well as a compiled town plan of the affected buildings (Figure 13).

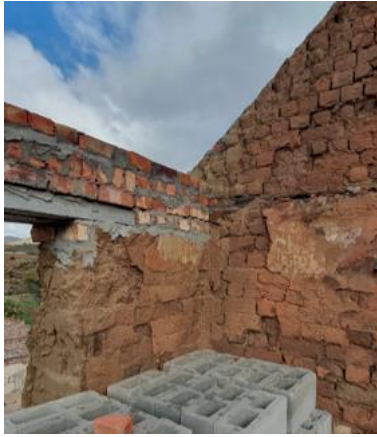
Figure 18: Raised side. (Author)

These transgressions mainly related to raising the side walls of the houses to gain additional internal height. The walls were built up to the gable acroteria which meant there was no remaining space for a parapet at the gable ends (Figure 18). This in turn led to gables being broken down or being sheeted over to accommodate the new finished roof level (Figures 19 and 20). In other instances, the gables had been raised (Figure 21). The gables are a prominent part of the streetscape and were nearly all intact after the fire. Fortunately, much of this work was halted by HWC and the Church before roofing commenced and before further damage could be caused to the gables.

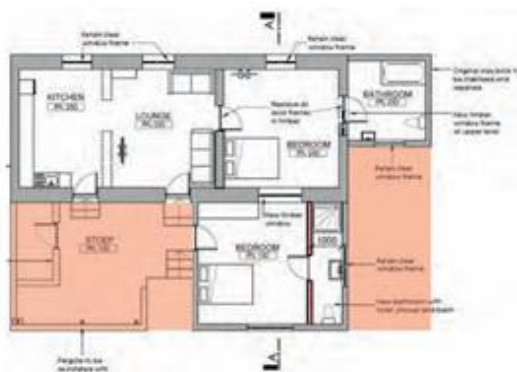
Figure 22: 7 Tra Tra Street. (Gabriel Fagan Architects, 2021)

Of extreme concern was the rebuilding of 7 Tra Tra Street where the wide street-side stoep had been incorporated into the house and additional area had been added to the northeast side by building into the side lane, all of which was now under a single roof covering the whole building. The old building form or gables were no longer visible. This house remains an over-scaled disruptive element in the middle of Tra Tra Street at the time of writing (Figure 22).

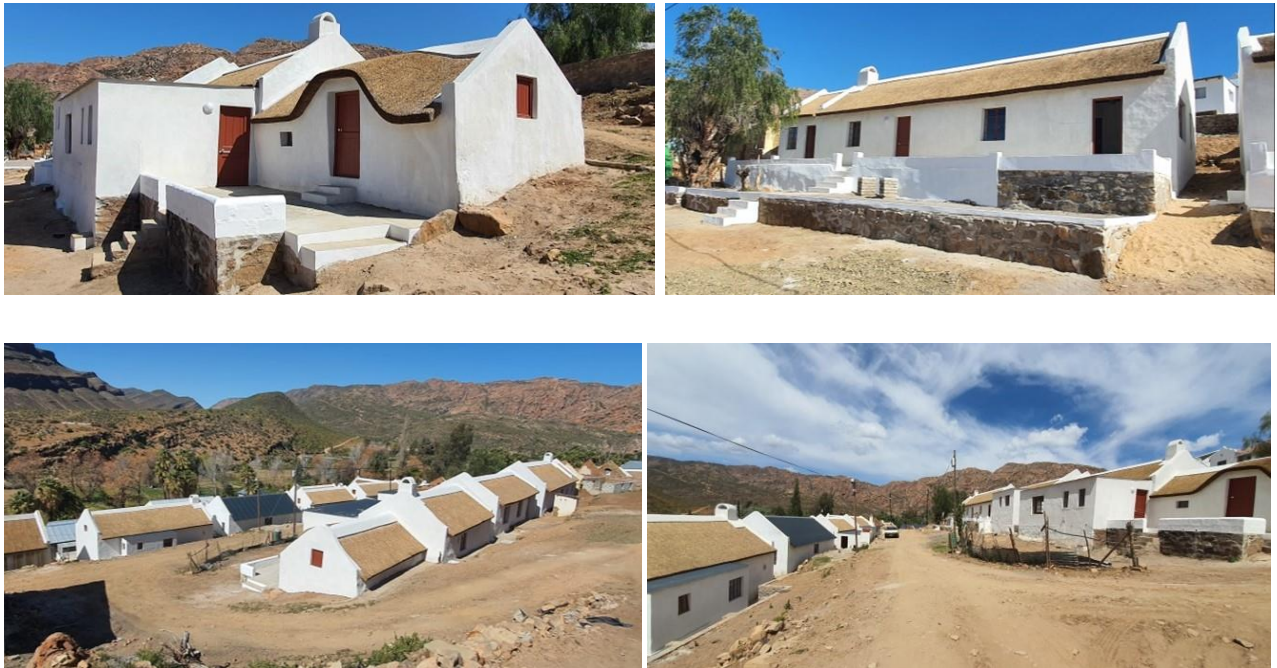
Figure 23: Completed buildings.

By September 2022, 14 houses were handed over to residents in emotional circumstances of relief for the people to be back in their own homes. A further 6 houses were handed over in similar circumstances in October 2022. During the handovers, many of the residents trailed the Rupert Foundation representative, Church leaders and Consultants to the home of the next owner and, as a group, toured the house before
